Monitoring the Environmental Quality of Florida Keys Canals

Final Report

Prepared for the Village of Islamorada, Monroe County, Florida

February 2020

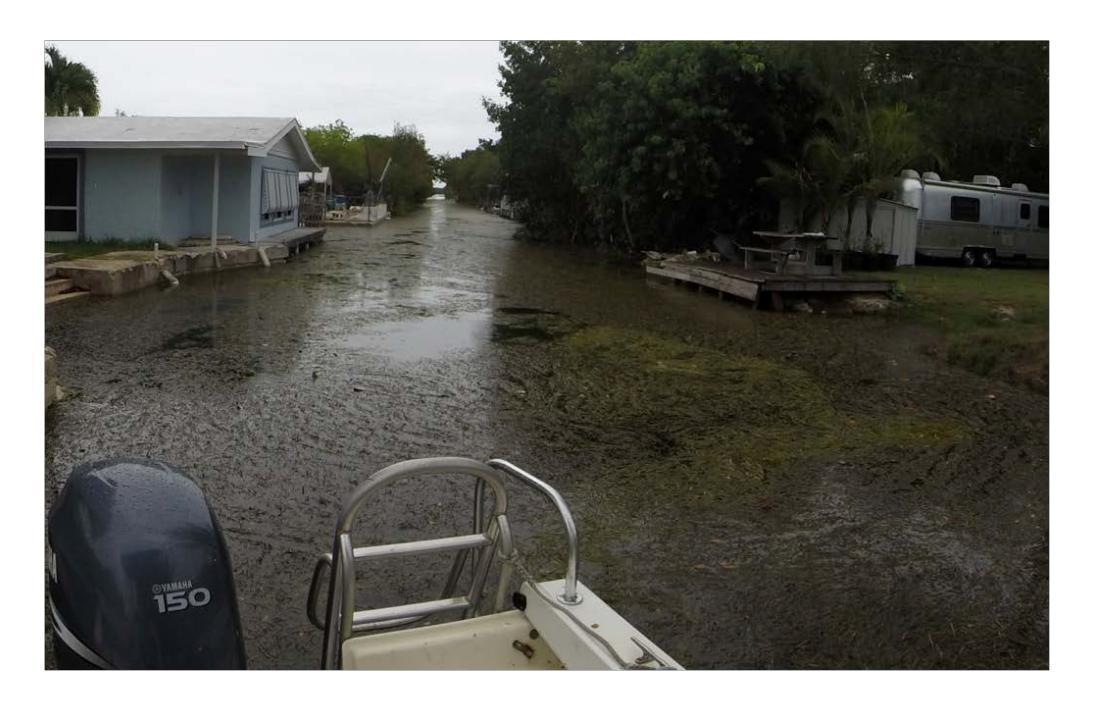
Figure 1.1: Seagrass wrack blown into Canal 263 floats on the surface before it sinks to further accumulate within and impair the bottom waters

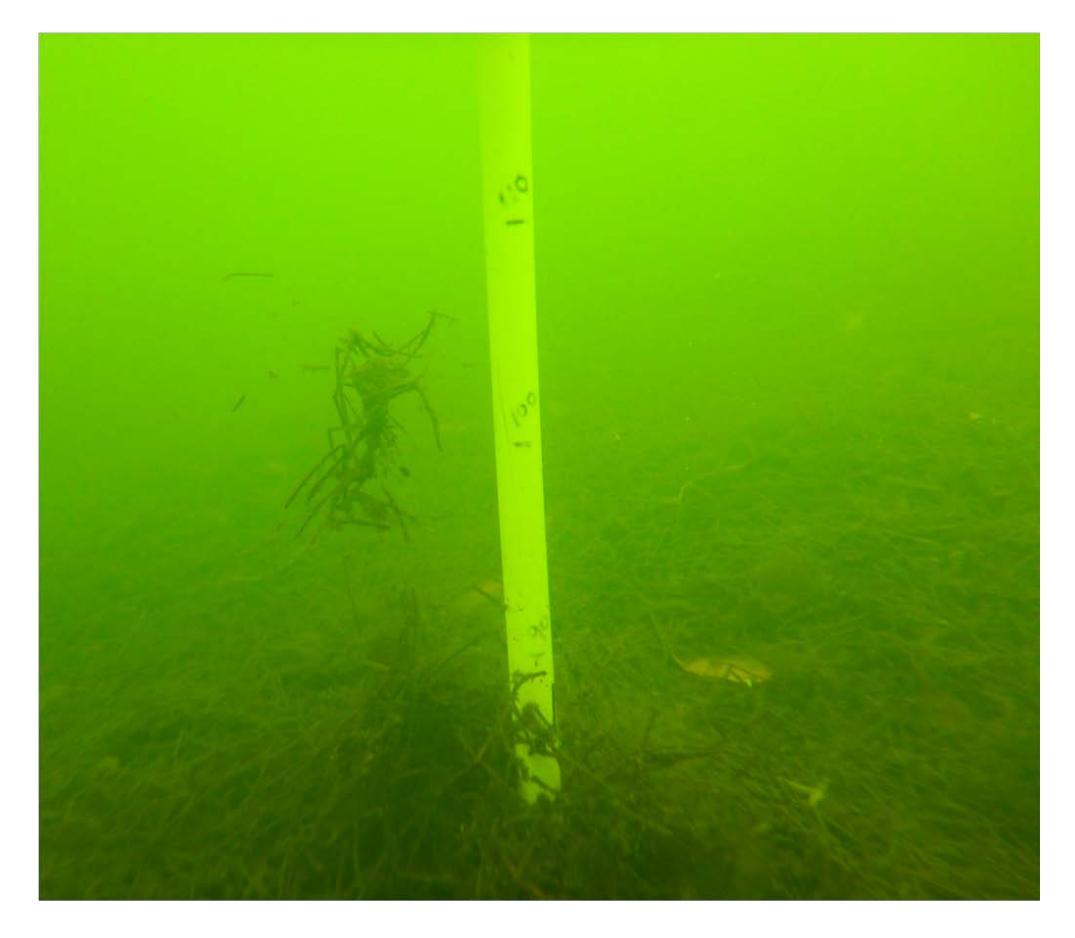
When seagrass wrack and other organic matter sinks and has not completely decomposed, the remaining material can create a fine, low-density muck that accumulates over time, and in some cases can become several meters thick (Fig. 1.2). Seagrass and algae found in South Florida are adapted to the sandy, carbonate sediments of the Florida Keys, though are poorly suited for growth in the low-density, unconsolidated organic material found in impaired canals.

Figure 1.2: Seagrass wrack and impaired water accumulating inside a canal. Over 80 cm of lightweight organic material has settled within this canal on eastern Big Pine Key. The sediment surface consists of dead plant material rather than sand, making it unsuitable for plant growth and as a habitat for benthic animals.

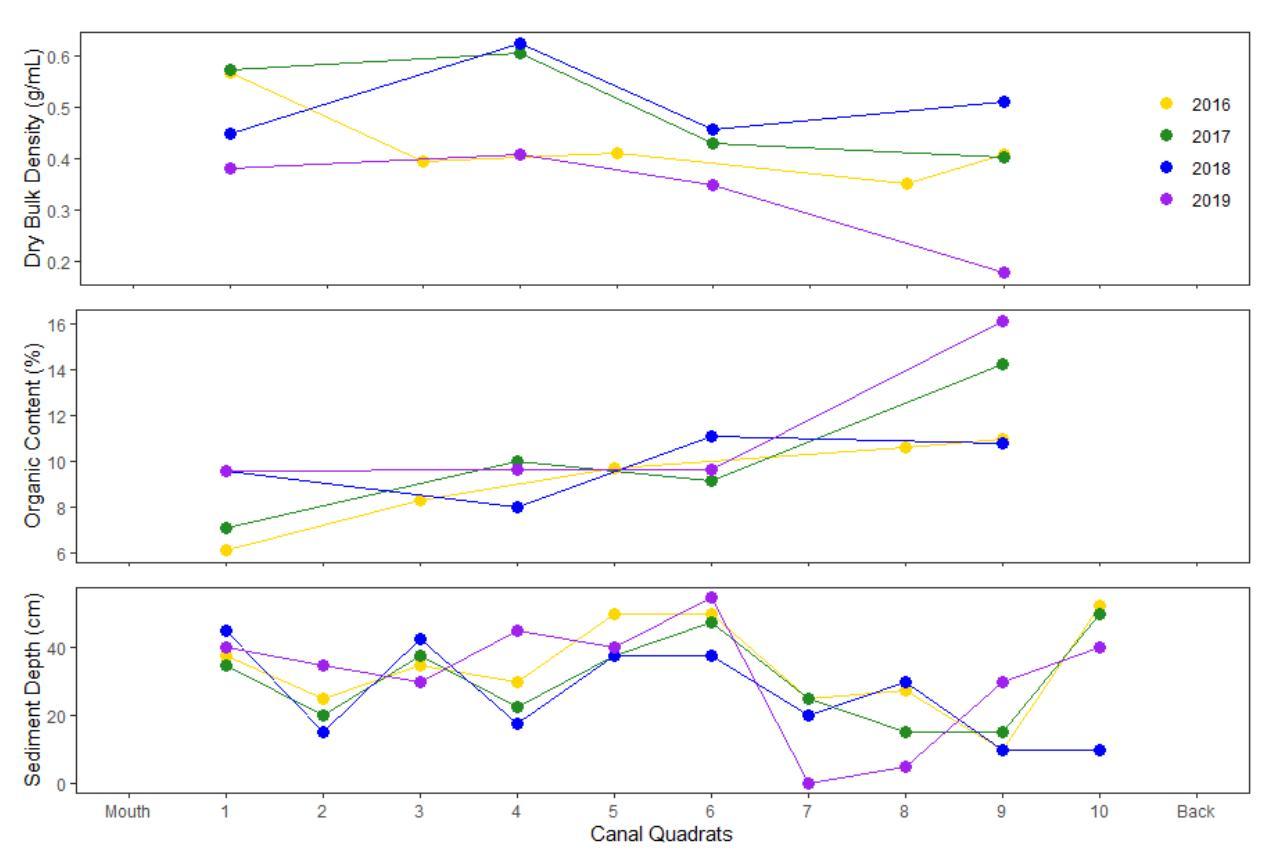
Sediment density, organic content and depth in Canal 114 varied greatly from the mouth of the canal to the rear (Fig. 3.18). Generally, sediment density and depth decreased from mouth to rear, while organic content increased from mouth to rear (Fig. 3.18). SAV in Canal 114 was never observed beyond monitoring station 6 and was only observed at low densities in the front portion of the canal (Fig. 3.19). No SAV measurements were collected outside the mouth of Canal 114 because the canal is located off Tavernier Creek (Fig. 3.19).

Figure 3.18: Changes in sediment dry bulk density (top), organic content (middle) and sediment depth (bottom) throughout Canal 114 over time.

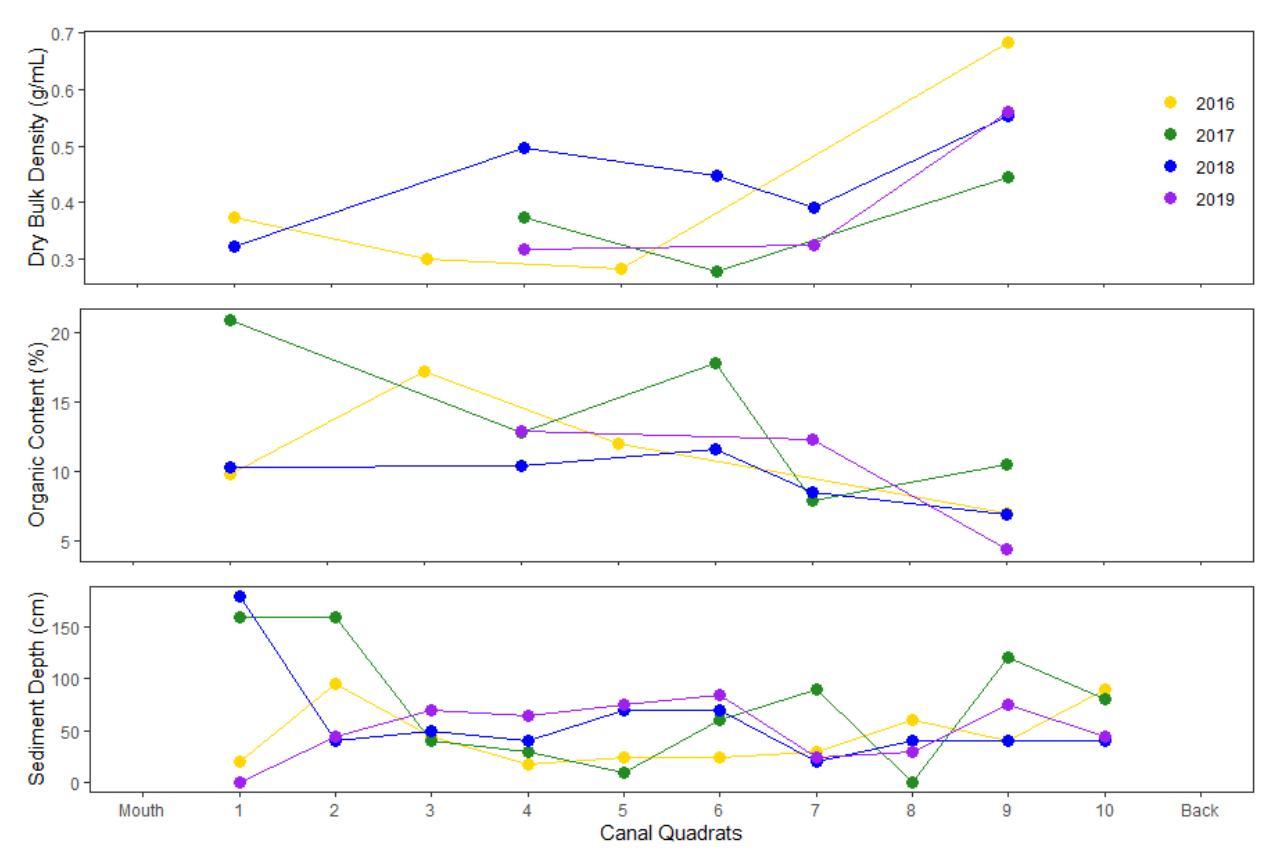
Sediment density, organic content, and depth were all variable throughout Canal 118 (Fig. 3.20). Sediment density typically increased from mouth to rear, while organic content decreased from mouth to rear (Fig. 3.20). Sediment depth was greatest at monitoring station 1 near the mouth in 2017 and 2018, but highest at monitoring station 6 in 2019 and monitoring stations 2 and 10 in 2016 (Fig. 3.20). Moderately dense SAV was observed outside the mouth of the canal and sometimes in through monitoring station 2 (Fig. 3.21). SAV was not observed further into the canal, except for one instance in 2016 at monitoring station 6 (Fig. 3.21).

Figure 3.20: Changes in sediment dry bulk density (top), organic content (middle) and sediment depth (bottom) throughout Canal 118 over time.

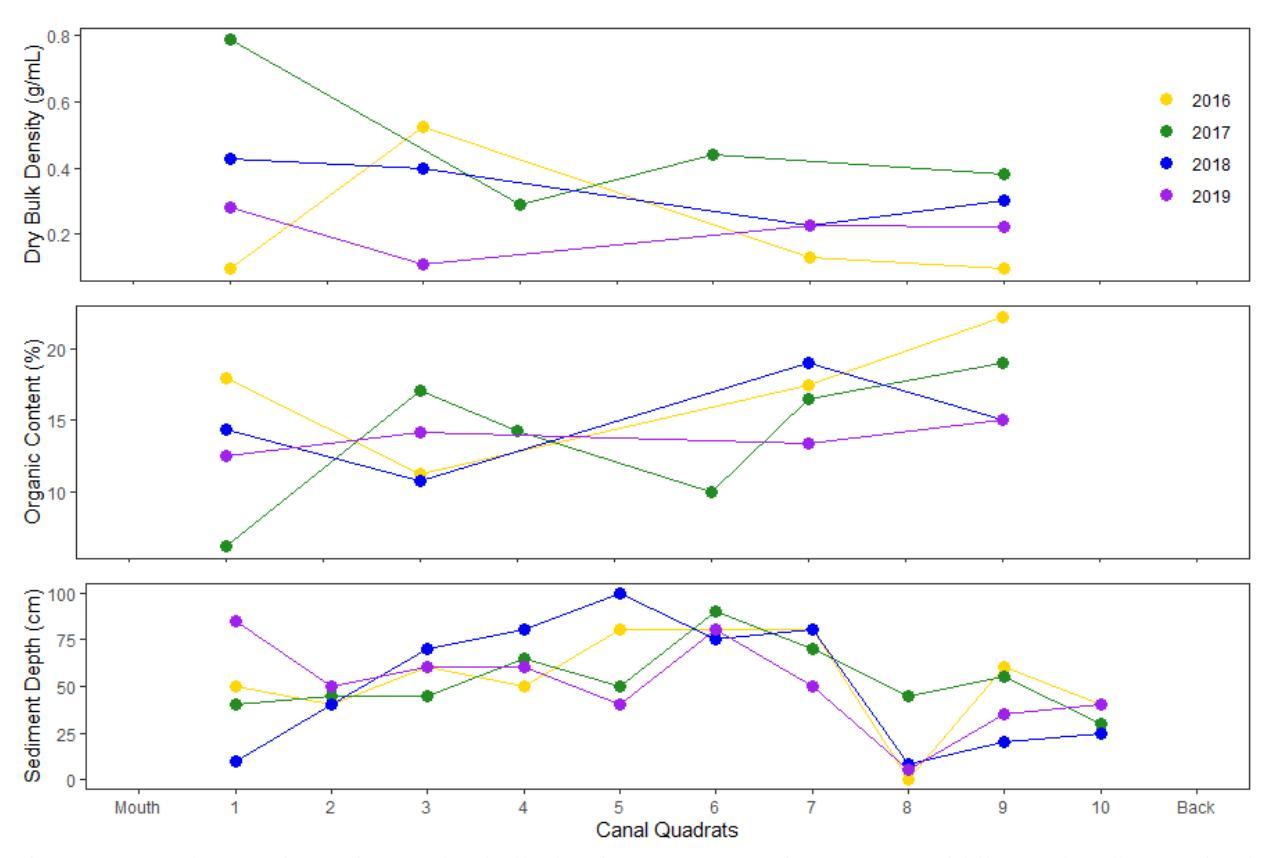
Sediment density, organic content, and depth varied greatly for Canal 152, both between monitoring stations within the canal and across years (Fig. 3.28). Sediment depth was typically higher in the middle of the canal and quite low at monitoring station 8 (Fig. 3.28). SAV was found in moderate to high densities outside of Canal 152 but was typically not found inside the canal except for on a few occasions near the mouth and once at monitoring station 5 in 2019 (Fig. 3.29).

Figure 3.28: Changes in sediment dry bulk density (top), organic content (middle) and sediment depth (bottom) throughout Canal 152 over time.

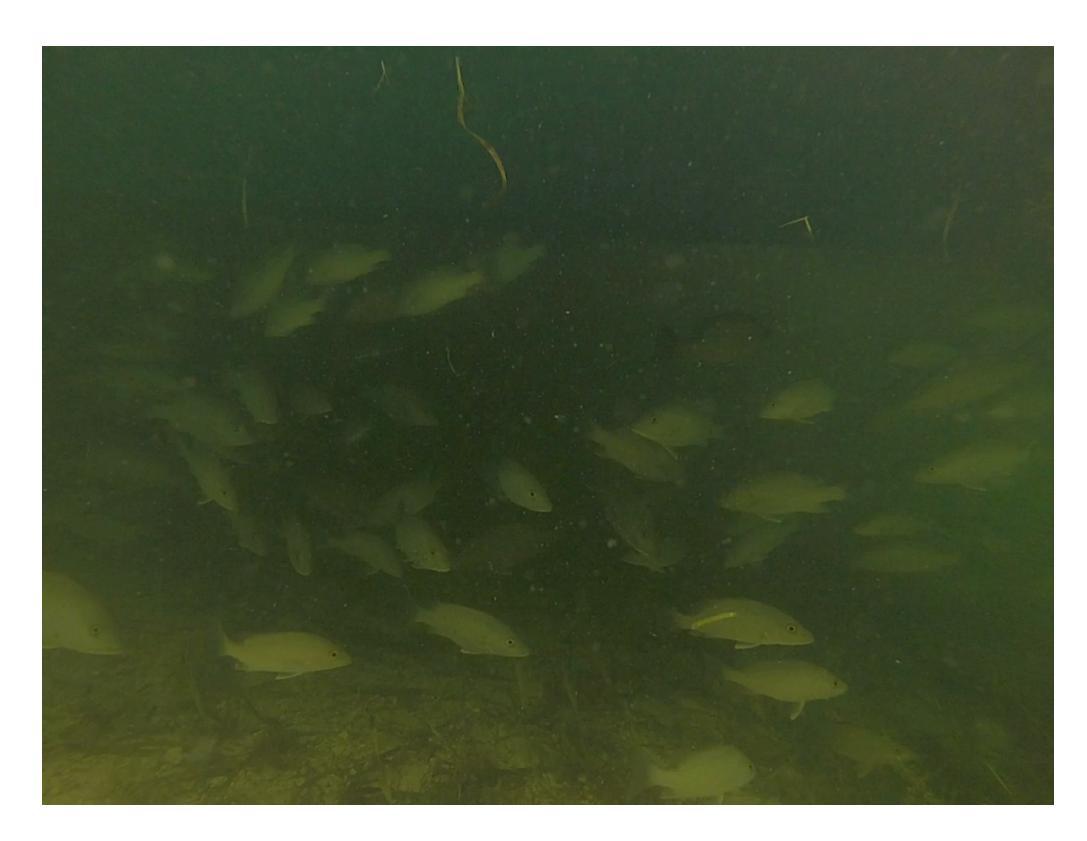
Figure 4.4: Dozens of mangrove snapper observed in the rear of Canal 472 after the opening of the culvert.
