Canal Restoration in Monroe County Benthic Monitoring Report

Jason Howard and James Fourqurean
Seagrass Ecosystems Research Lab
Florida International University

WATER QUALITY PROTECTION PROGRAM CANAL RESTORATION ADVISORY SUBCOMMITTEE
January 16th, 2015

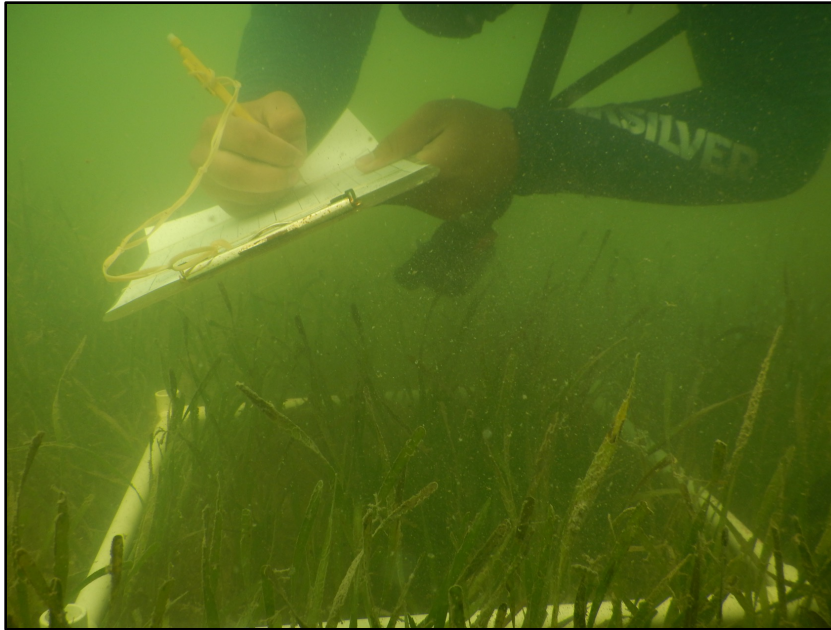
50 meters outside canal

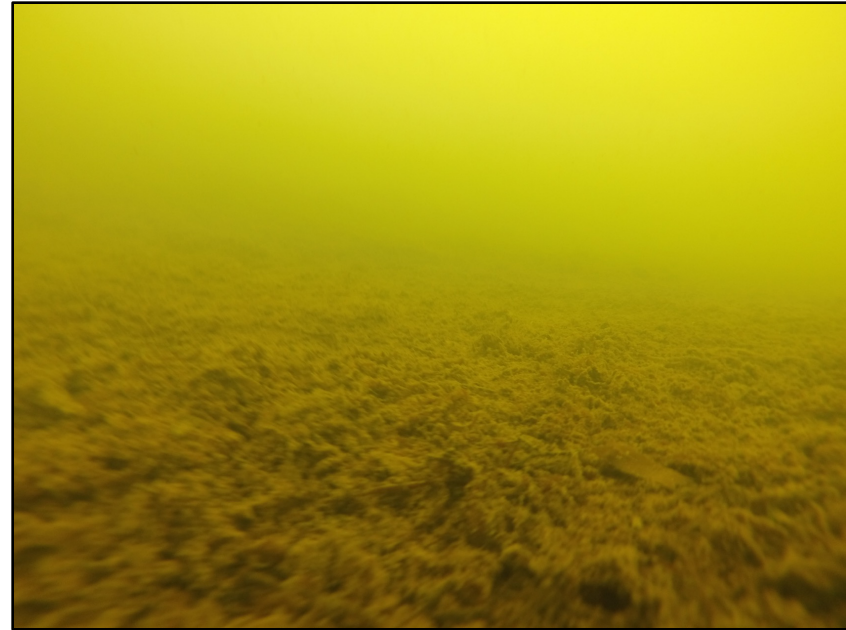
25 meters inside canal

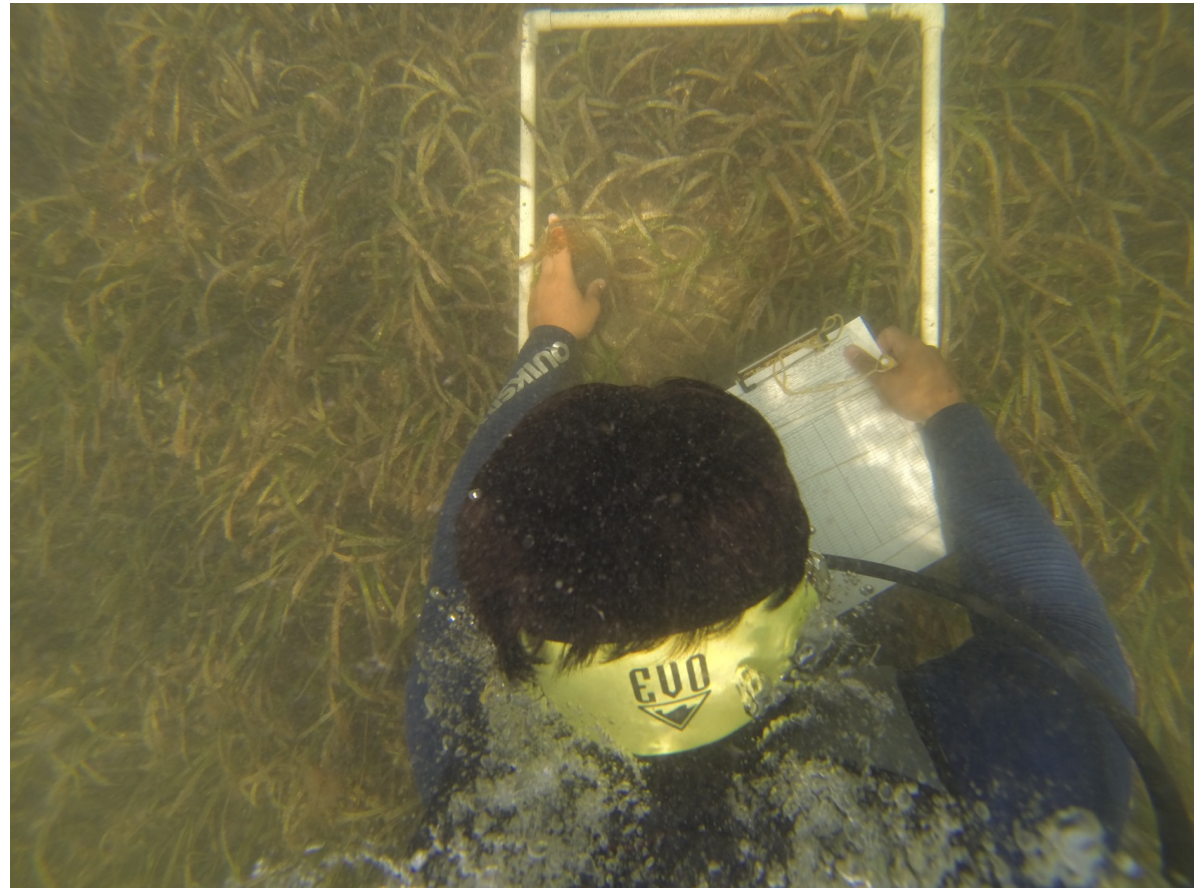
Benthic cover

Quantifying species of seagrass, algae, sponges, corals using Braun-Blanquet scoring

Single Individ. = 0.1

<5 indiv. = 0.5

>5 indiv. and < 5% = 1

5 - 25% = 2

25 - 50% = 3

50 - 75% = 4

75 - 100% = 5

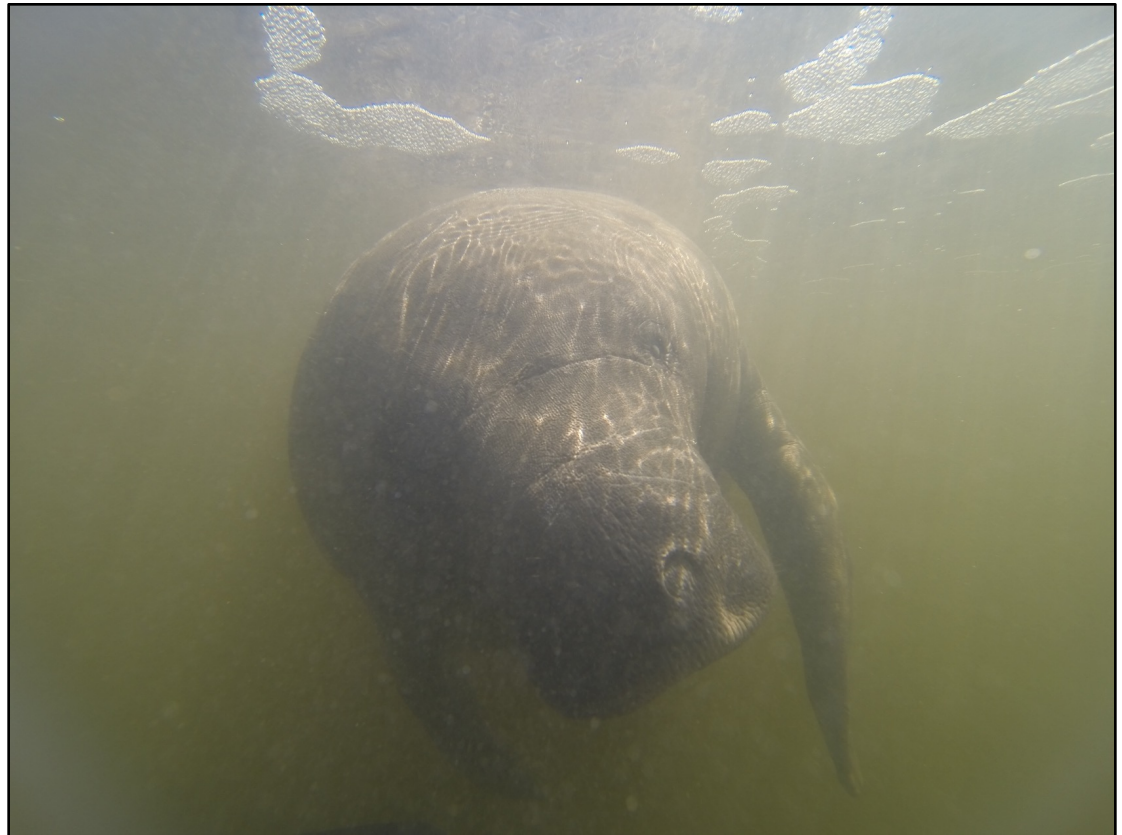
Animal Surveys

Animal surveys using the Roving Diver Technique
-diver swims freely around a central point

All animal encounters
are recorded

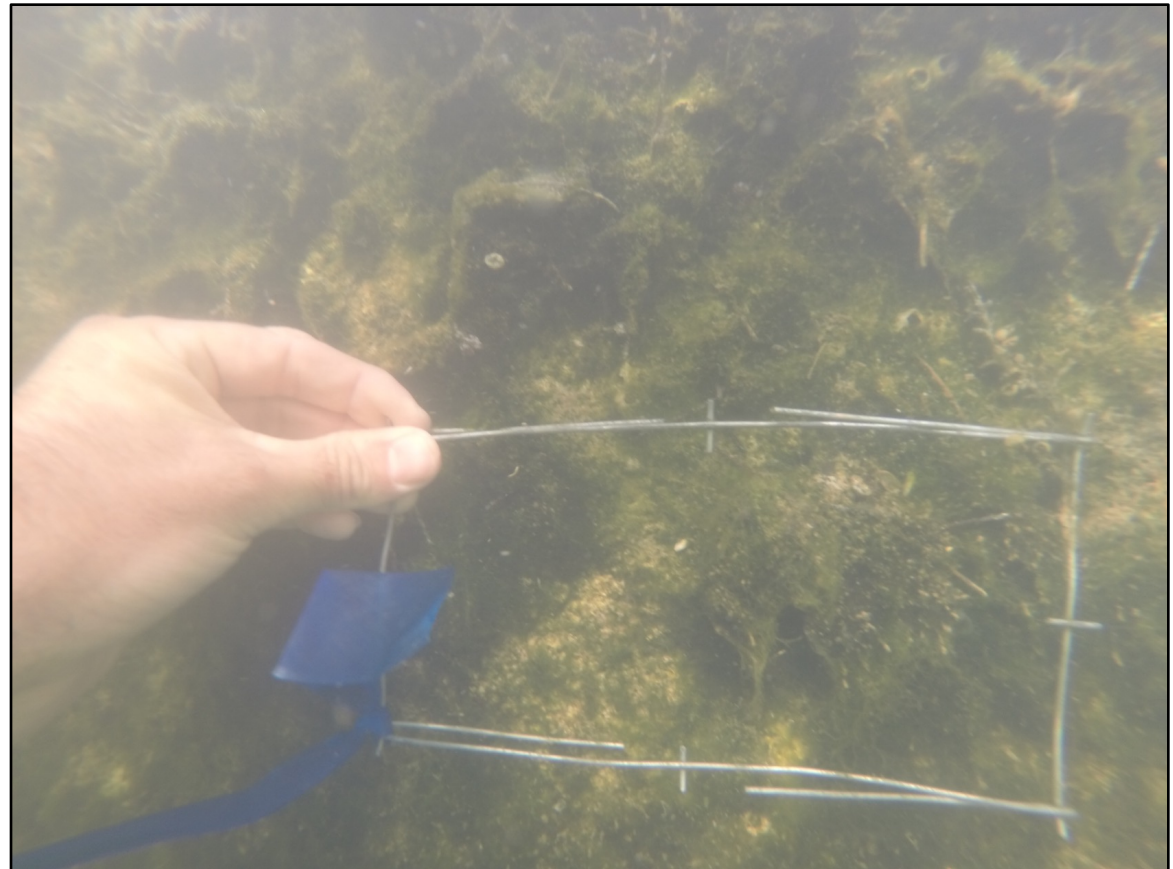
Seawall

Quantifying organisms on canal seawall using a modified Braun-Blanquet technique

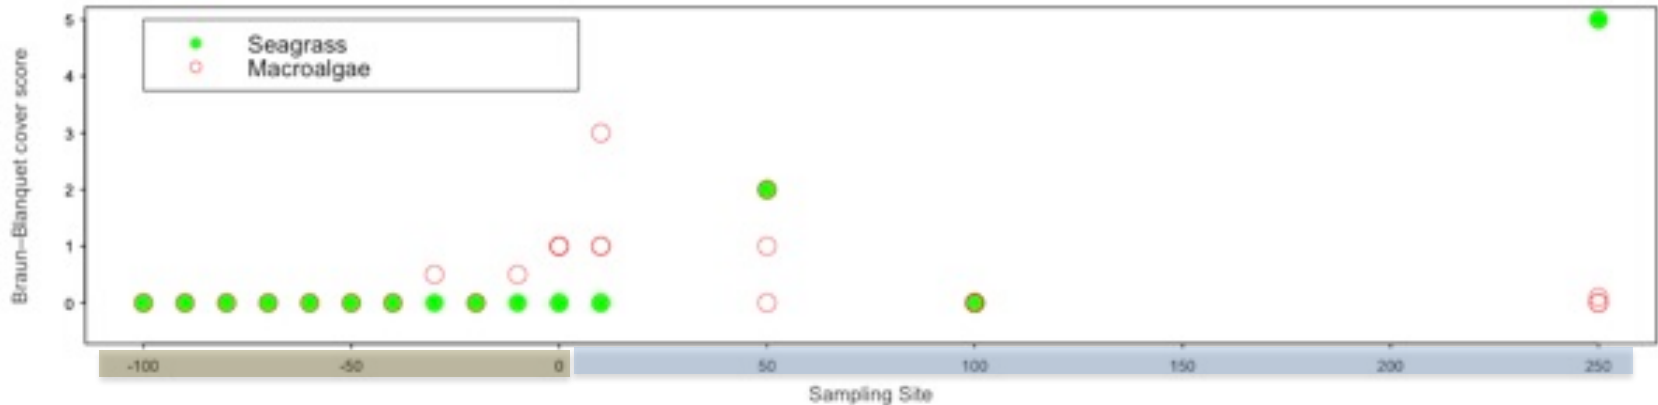
Canal 137 – Treasure Harbor
Plantation Key

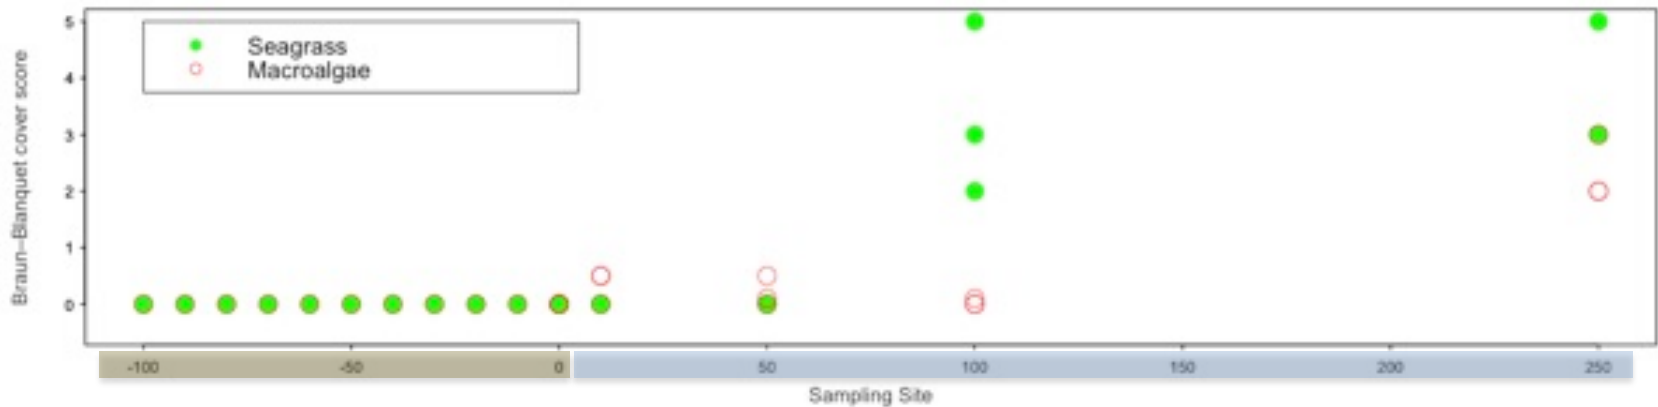
Canal 290 - Hollerich Subdivision
Big Pine

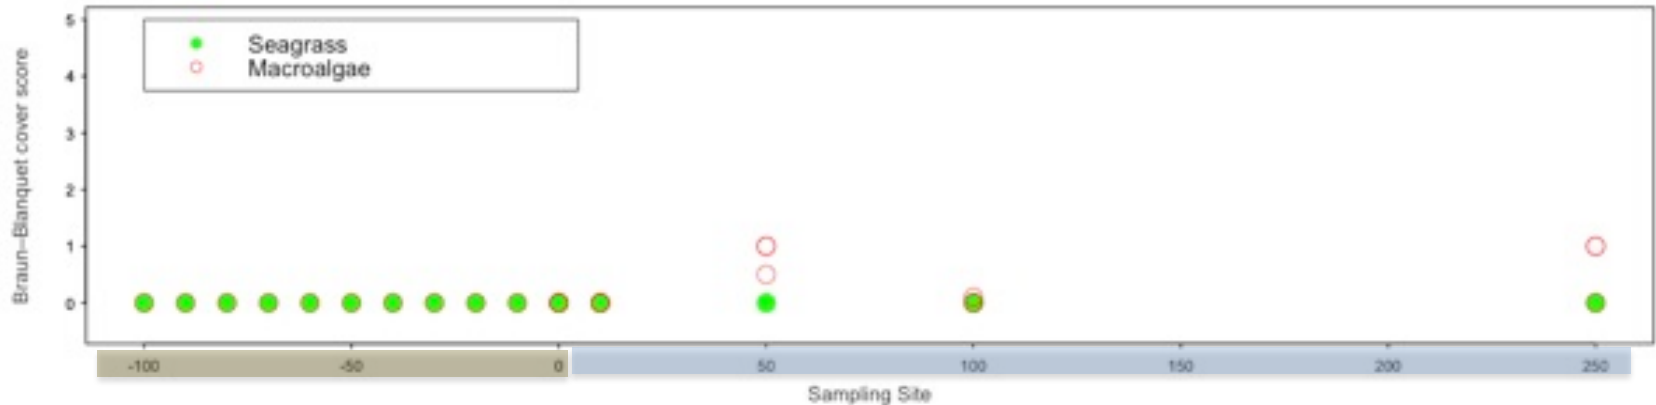
Canal 293– Between Avenue I and Avenue J
Big Pine

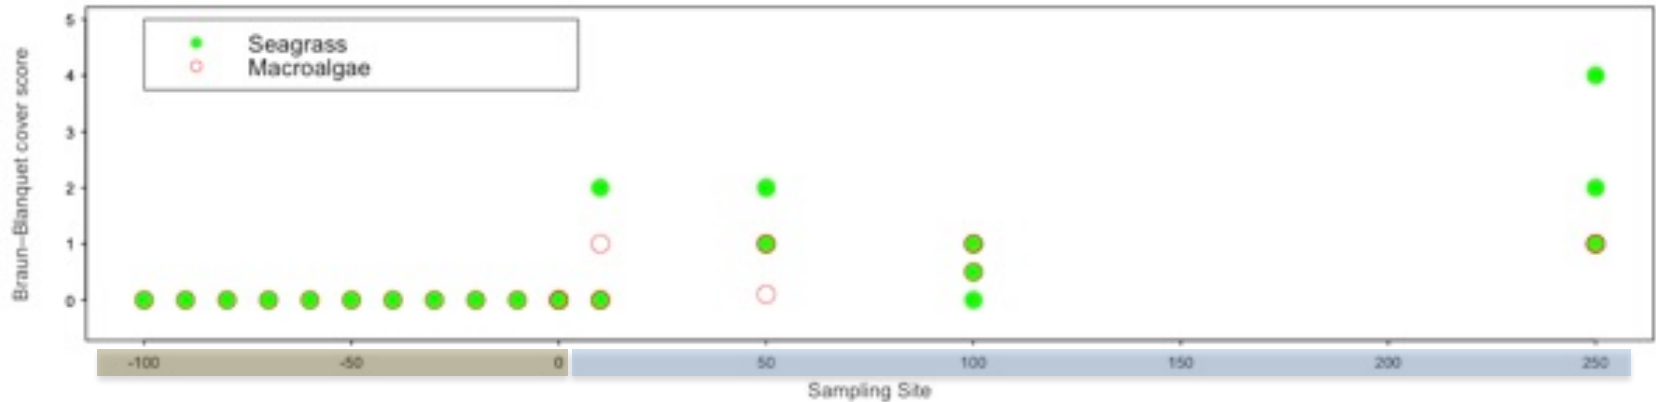
Canal 472- Geiger Mobile Homes Subdivision
Big Pine

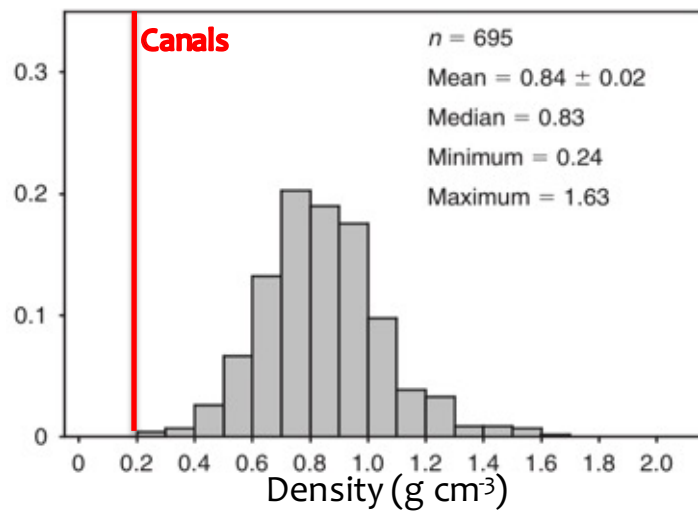
Florida Bay Seagrass Sediment

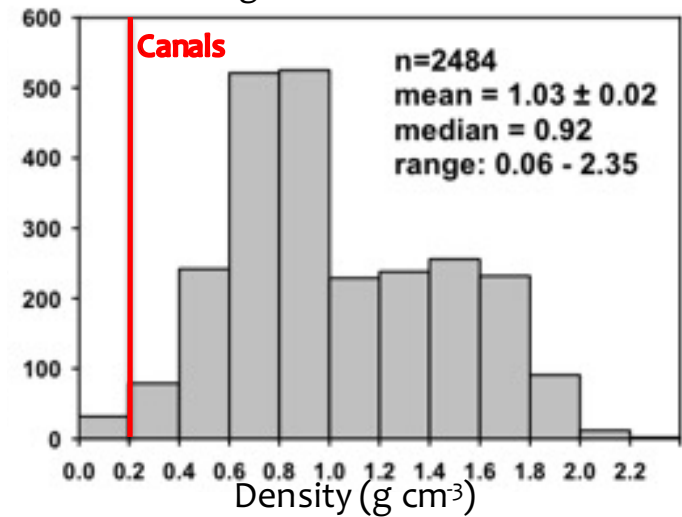
Global Seagrass Sediment

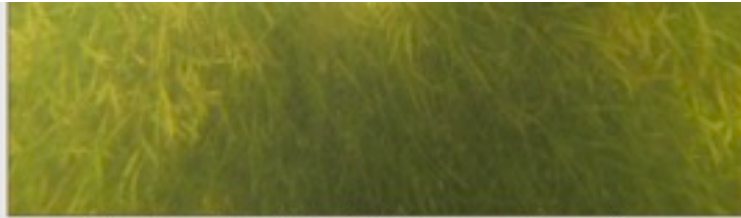
Seagrass is abundant outside canal. There is NO living seagrass within canal 290.

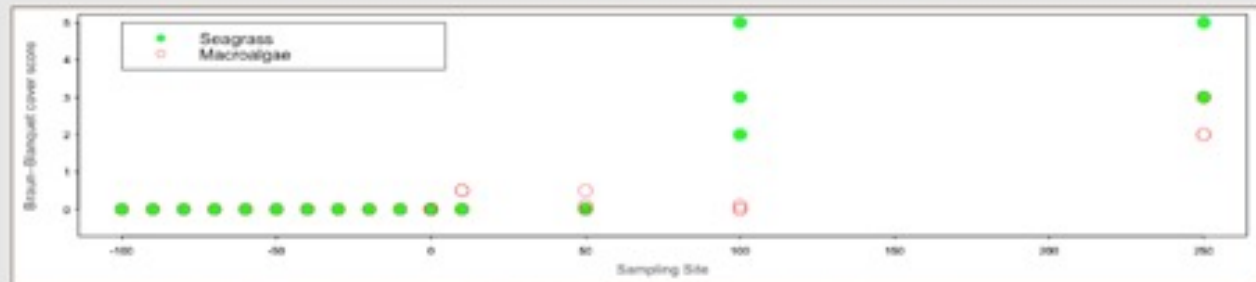
Seagrass and Algae coverage from 250meters outside canal to the back. Note decreases of both at 100 meters outside
