Monitoring the Environmental Quality of Florida Keys Canals

Final Report

Prepared for the Village of Islamorada, Monroe County, Florida

February 2020

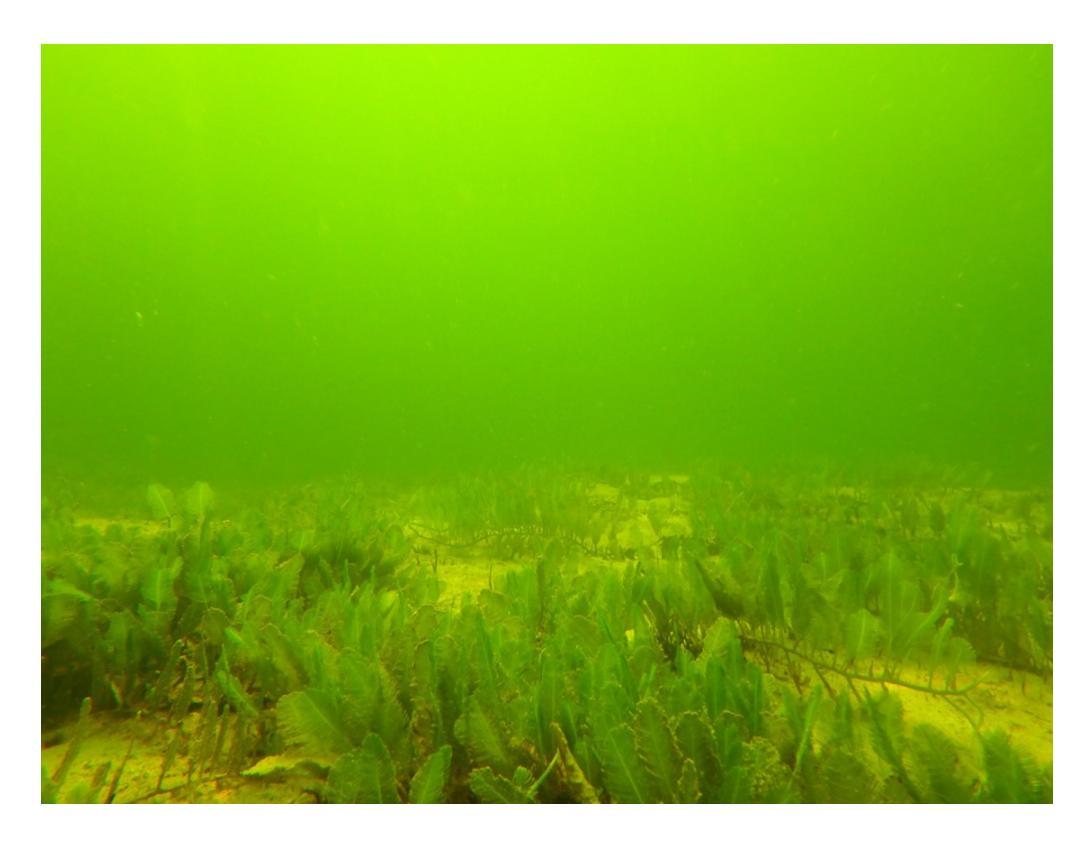
The backfilling of Canal 29 resulted in immediate improvements in sediment conditions and benthic vegetation. Sediment density was increased beyond the average value for the Florida Keys, making it suitable for plants to take root. Decomposing, organic-rich sediment was buried by the added carbonate fill, preventing it from further affecting water column oxygen and nutrient levels. The decreased water depth allowed light to penetrate to the sediment. As a result, there were measurable increases in benthic vegetation, fish diversity and abundance and inhabitants of the sea walls.

The backfilling quickly addressed many of the original causes of impaired water quality, though the influx of organic-rich sediments from outside the canals are beginning to affect sediment characteristics towards the canal mouth. Over time, continued influx of organic material may turn the newly formed sandy bottoms back into muddy, organic sediments. For the improvements to water and sediment quality resulting from backfilling to persist, organic matter and wrack inputs to Canal 29 must be addressed.

Figure 4.3: Benthic algae taking root in newly backfilled sediment in Canal 29. Prior to backfilling, light did not penetrate more than 10 ft into the water.
