# Status of Residential Canal Benthic Habitats in the Florida Keys and the Effectiveness of Remediation Technologies Project Report

Prepared for the Water Quality Protection Program, Florida Keys National Marine Sanctuary  
& The Village of Islamorada, Monroe County, Florida

Jason L. Howard, Sara S. Wilson, Christian C. Lopes, James W. Fourqurean

November 2018

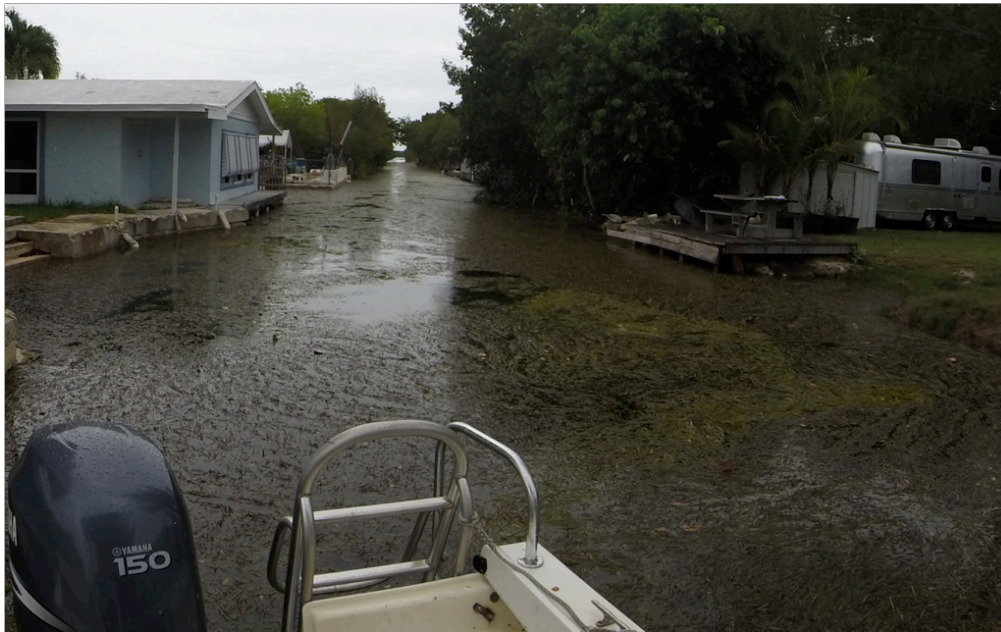
Figure 1.1: Seagrass wrack blown into Canal 263 floats on the surface before it sinks to further impair and accumulate in the bottom waters.

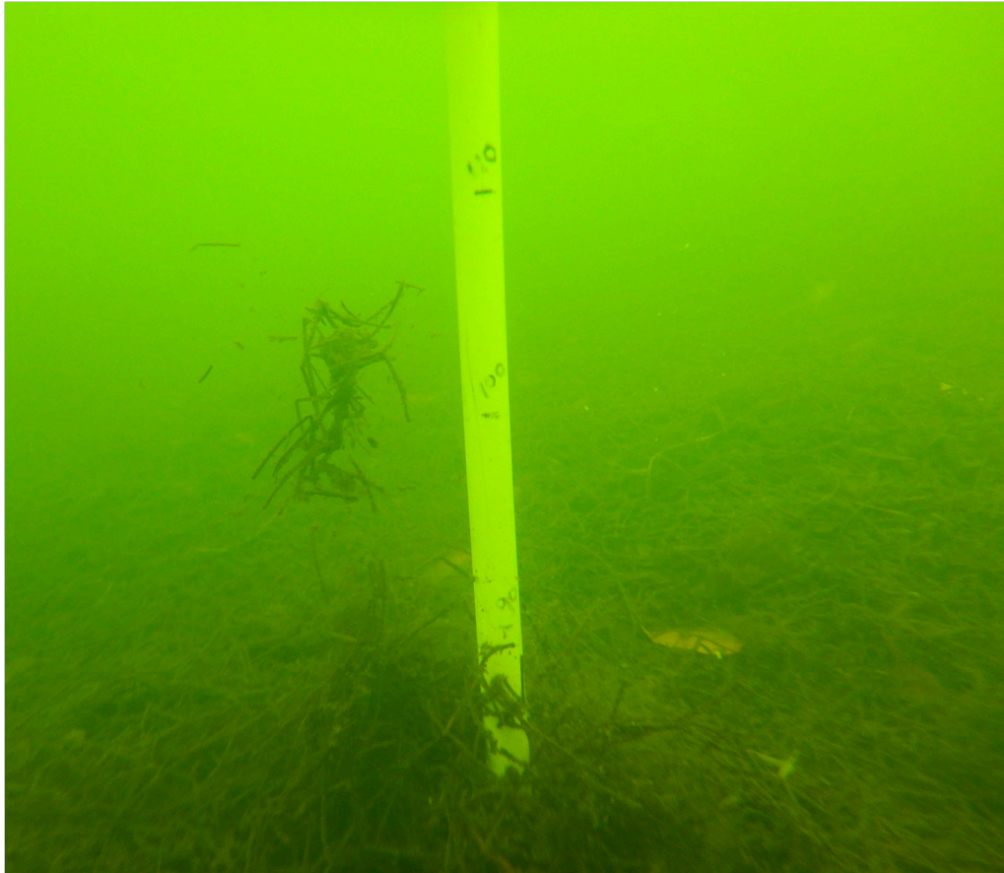
Figure 1.2: Seagrass wrack and impaired water accumulating inside a canal. Over 80 cm of lightweight organic material has settled within this canal on eastern Big Pine Key. The sediment surface consists of dead plant material rather than sand, making it unsuitable for plant growth and as a habitat for benthic animals.

Seagrass wrack and other organic material is not completely decomposed, and the material remaining can create a fine, low density muck that accumulates over time, and in some cases can become several meters thick (Fig 1.2). Seagrass and algae found in South Florida are adapted to the sandy, carbonate sediments of the Florida Keys, though are poorly suited for growth in the low-density, unconsolidated organic material found in impaired canals.

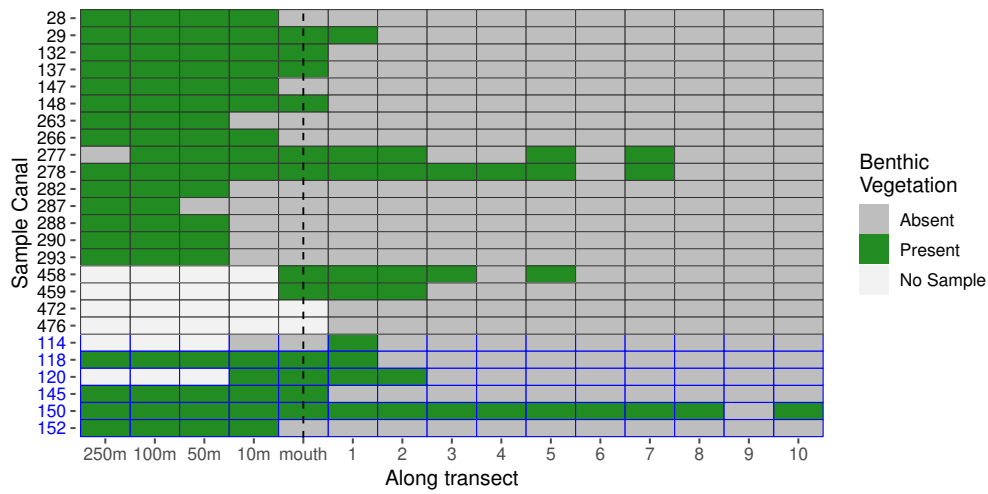
Figure 3.1: Presence of benthic vegetation along canal transects from 250 m outside monitored canals until the 10<sup>th</sup> monitoring site at the canal rear. Canals highlighted in blue are part of the concurrent monitoring program in Islamorada and data represent observations from the first year of project monitoring. Sites 1 - 10 are equally spaced from mouth to rear, and canal mouth is highlighted with a dotted line.

Seagrass meadows and macroalgae are important ecosystem engineers in coastal South Florida but are markedly absent from the sampled canals (Fig 3.1). Out of the 19 demonstration project canals sampled, only three contained benthic vegetation within the canal during the first year of monitoring. Of those three, only two supported vegetation in the rear half, the portion of canals with typically the worst water quality. Benthic vegetation was present outside the mouths of canals, starting typically at the mouth or 10 m outside. It is important to note that canals 458 and 459 have mangroves outside the mouth of the canal, an unsuitable habitat for seagrasses and macroalgae regardless of water quality.

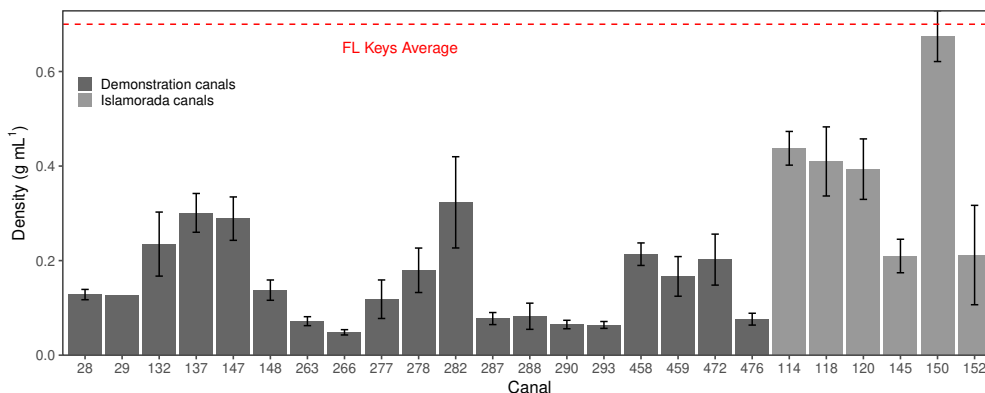
Figure 3.6: Values of sediment density (measured as dry bulk density) during the first year of monitoring, prior to demonstration technologies. Values represent mean  $\pm$  SE compared to the average (red line) for natural waters in the FL Keys from Howard, 2018.

Sediments assessed during baseline, pre-technology monitoring were categorized as either "unconsolidated organic material", "mud" or "sandy mud" across all sites. Average sediment density (measured as dry bulk density) within a canal ranged from  $0.05 \pm 0.03 \text{ g cm}^{-3}$  in Canal 266 (Big Pine Key) to  $0.70 \pm 0.05 \text{ g cm}^{-3}$  (similar to the FL Keys regional average; Howard 2018) in Canal 150 in Islamorada (Fig 3.6). Canal sediments from monitored canals were less dense than Florida Bay and the Florida Keys ( $1.0 \pm 0.1$  and  $0.73 \pm 0.04 \text{ g cm}^{-3}$ , respectively; Fourqurean et al. 2012a; Howard 2018), though sediments of Islamorada canals were over twice the average density of those from Demonstration project canals during the initial year of monitoring ( $0.44 \pm 0.03 \text{ g cm}^{-3}$  compared to  $0.18 \pm 0.01 \text{ g cm}^{-3}$ ).

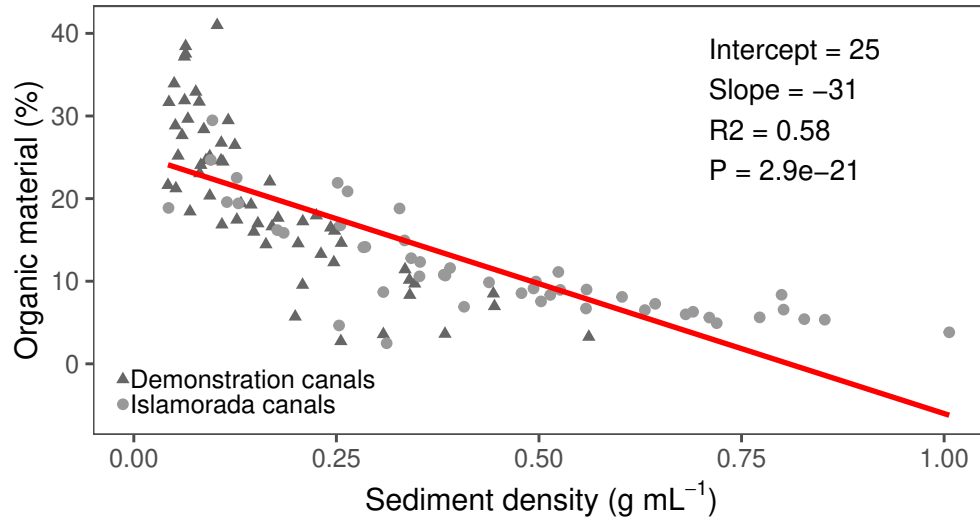
Figure 3.7: Correlation between sediment density and percent organic material of sediments. The negative slope indicates denser sediments contain less organic material.

Lighter, less dense sediments correlated with a higher percentage of organic material, measured as loss-on-ignition, with density alone explaining over 50% of the variation in organic material content (Fig 3.7).

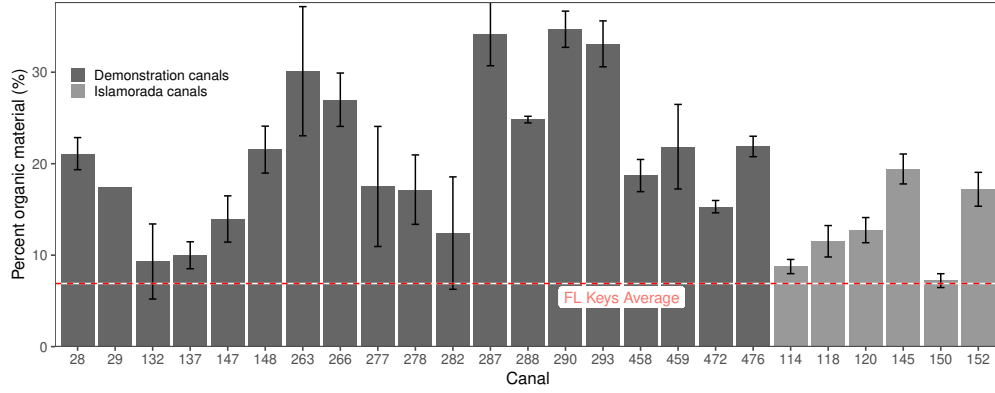
Figure 3.9: Values of sediment percent organic material (measured as LOI) during the first year of monitoring, prior to demonstration technologies. Values represent mean  $\pm$  SE compared to the average (red line) for natural waters in the FL Keys from Howard, 2018.

Surface sediments ranged 3-fold in percent organic material across canals, with those on the eastern shore of Big Pine Key having the highest values (Canals 263, 287, 288, 290, and 293; Fig 3.9). Sediment  $C_{org}$  and N content was also highly variable across canals with most extreme measurements on Eastern Big Pine Key. Patterns of Organic material and  $C_{org}$  are similar across canals (Fig 3.10), though P varies independently, with Canal

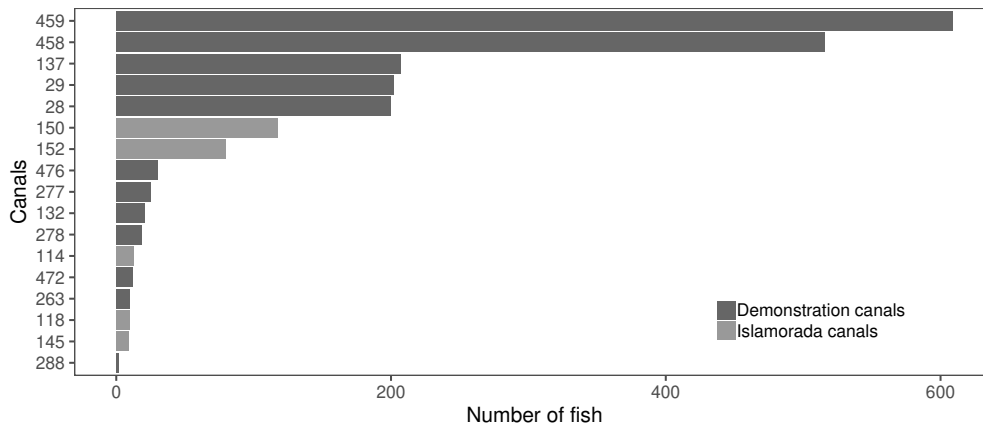
Figure 3.13: Average number of fish observed during each campaign during the first year of monitoring. Counts were estimated for encounters of over 20 individuals.

During the first three sampling events (Spring 2014, Fall 2014, and Winter 2015) of the Demonstration project, there were a total of 61 fish encounters, ranging from 1 to 500 individual fish per encounter. There were 12 species observed across the monitored canals during this period with mangrove snapper (*Lutjanus griseus*) being the most common, followed by minnows (*Anchoa mitchilli*), barracuda (*Sphyraena barracuda*), and needle-fish (family: *Belonidae*). Other species were rare, being observed only once or twice. Only six of the monitored canals had more than one species of fish during the first year of monitoring. Fish observations were not equally distributed across canals; less than 50 % of canals contained 90 % of the observed fish (Fig 3.13). It is important to note that fish surveys are heavily dependent on the visibility of water. As the monitored canals have been established as being impaired, it's likely that varying turbidity may influence the successful fish observation. Nevertheless, the pair of canals in Geiger Key (canals 458 and 459) had the highest average fish count during baseline monitoring due to schools of juvenile fish present, followed by Canal 137 on Plantation Key and the pair of canals on Key Largo (28 and 29). Three of these canals (137, 458, 459) also reported the highest number of fish species as well (Fig 3.14).

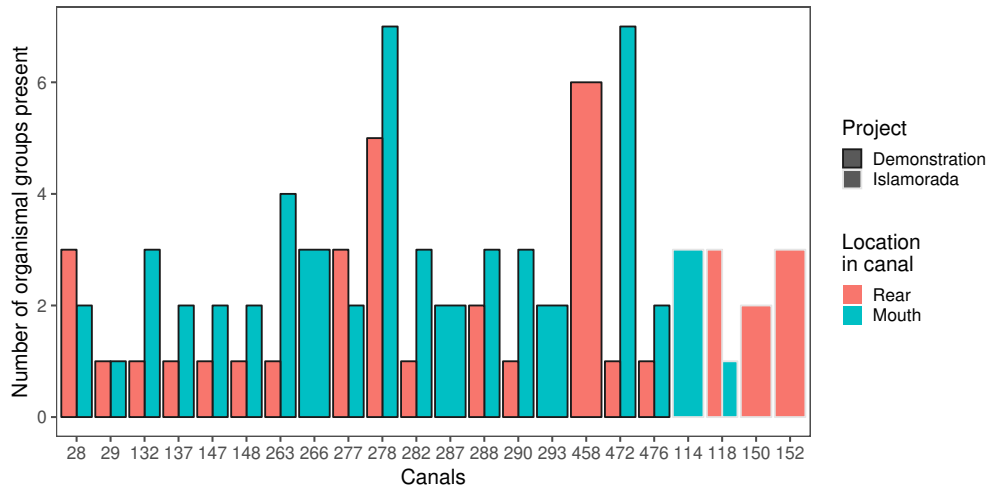
Figure 3.15: Average number of organismal groups (of 15 categories) observed on the seawall during the first year of monitoring. Seawall mouth and back refer to monitoring location within the canal, regardless of canal length. A list of organisms and abbreviations can be found in Appendix 4.

The walls of the canals were assessed for biodiversity at the canal mouth and rear. Organisms inhabiting the seawall were categorized into 15 taxonomic groups (appendix 4) and measured for density using the 5-point, modified Braun-Blanquet scale (appendix 2). There was a clear difference in the organism inhabiting the seawall of the canal mouth compared to that of the canal rear (Fig 3.15).

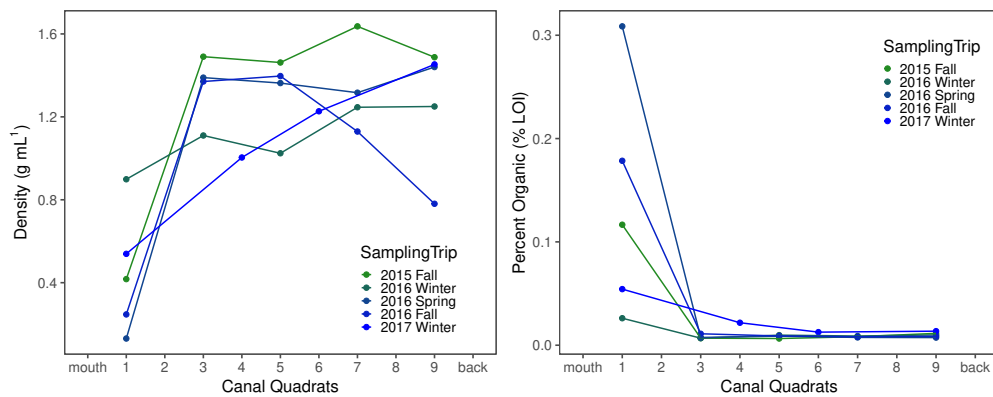
Figure 3.18: Changes in in sediment density and percent organic carbon throughout backfilled Canal 29 over time.

Sediment characteristics improved immediately after backfilling in 2015, though it is important to note that changes were not consistent nor stable. Post-backfilling sediment was higher in organic material (along with  $C_{\text{org}}$ , N, and P) and lower in density near the canal mouth and has fluctuated, particularly near the mouth over time (Fig 3.18)

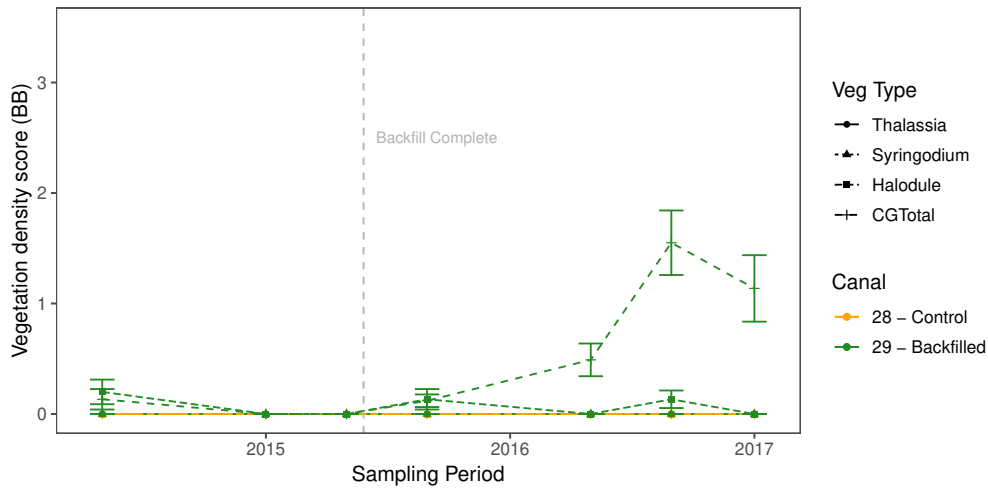
Figure 3.19: Increases in benthic vegetation in Canal 29 after backfilling. Points represent mean  $\pm$  SE of quadrats sampled.

Within one year of the backfilling, macroalgae (particularly species of *Penicillus* and *Halimeda*) began to colonize the benthos of the backfilled canal, forming dense patches in the rear half (Fig 3.19). During the fall 2015 campaign and again in fall 2016, the seagrass *Halodule wrightii* was found inhabiting the canal, approximately halfway between the canal mouth and rear.

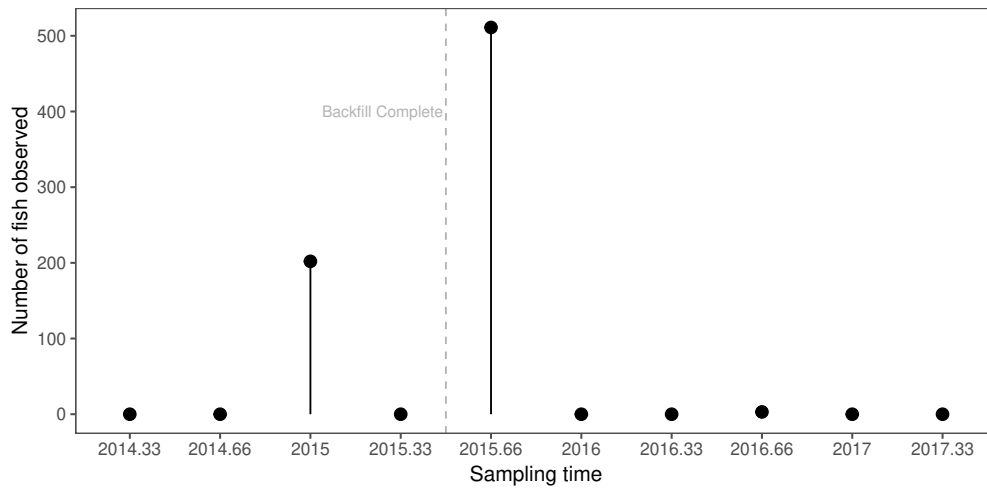
Figure 3.21: Number of fish observed in backfilled Canal 29 through project monitoring. Data represents sum of all fish encounters during a monitoring campaign.

curred once (in winter 2015) with observations of 4 needlefish and approximately 200 juvenile fish. After the backfilling there were fish encounters only in fall 2015, including the observations of mangrove snapper and unidentifiable jacks along with hundreds of juvenile fish (Fig 3.21). While diversity and number of fish were higher after backfilling, conclusions regarding fish communities are unable to be reached as 1) encounters were low overall, and 2) data is likely to be biased as the improved water clarity resulting from the backfilling may have increased post-treatment fish counts.

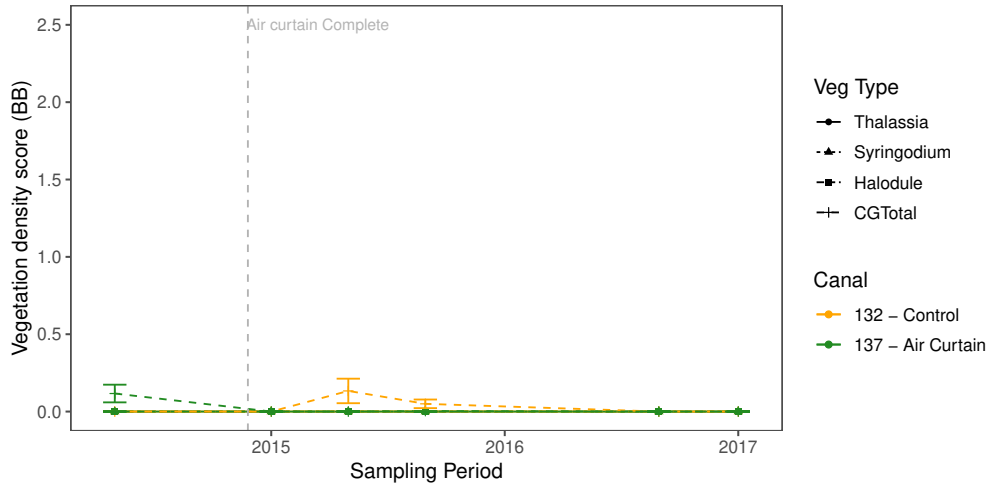
Figure 3.23: Changes in benthic vegetation density in Canal 137 compared to reference, Canal 132 over time. Data represent mean  $\pm$  SE, and the vertical grey line indicates when air curtain and aerator installation was finished.

Canal 137 received an air curtain in November 2014 to prevent the entry of wrack into the canal along with 6 aerators in addition to the 6 already in existence. The adjacent Canal 132 served as an experimental control. Benthic vegetation was extremely rare in both the experimentally altered canal and the reference, with only three observations of benthic vegetation throughout the monitoring program (two occurrences in Canal 137 and one in 132) all with low densities of calcifying green algae 3.23).

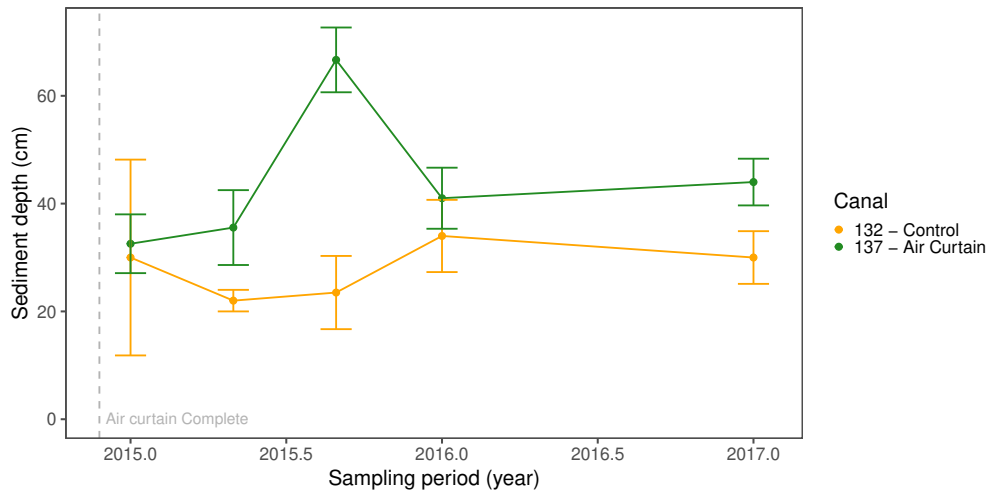
Figure 3.25: Sediment Depth in Canal 137 compared to its reference, Canal 132 over time. Data represent mean  $\pm$  SE, and the vertical grey line indicates when the installation of air curtain and additional aerators was finished.

There was no consistent difference in sediment depth between the Canal 137 with air curtain and additional aerators and its reference. In fact, average sediment depth was higher in the demonstration canal at three of five, post-installation monitoring periods (Fig 3.25).

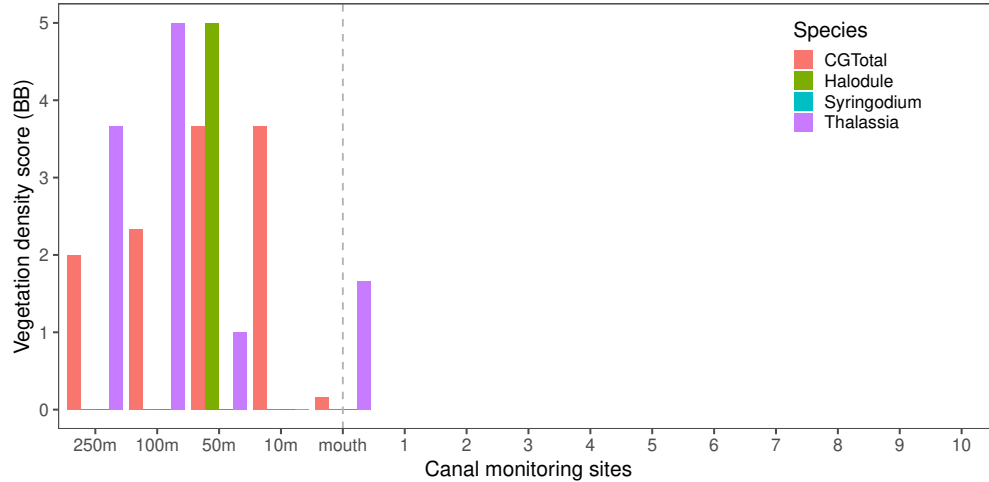
Figure 3.30: Average benthic vegetation from 250m outside Canal 148 to site 10 at the canal rear during the final year of monitoring (Spring 2016 through Winter 2017). Data represent average score of three measurements at each site for three consecutive sampling campaigns.

Seagrass detritus was a common occurrence in canals, but living benthic vegetation was completely absent from both canals throughout the monitoring. Observations of benthic vegetation begin outside the canal mouth, reaching the highest density 50 m - 100 m outside the canal where *Thalassia testudinum*, *Halodule wrightii*, and calcifying macroalgae were regularly found (Fig 3.30).

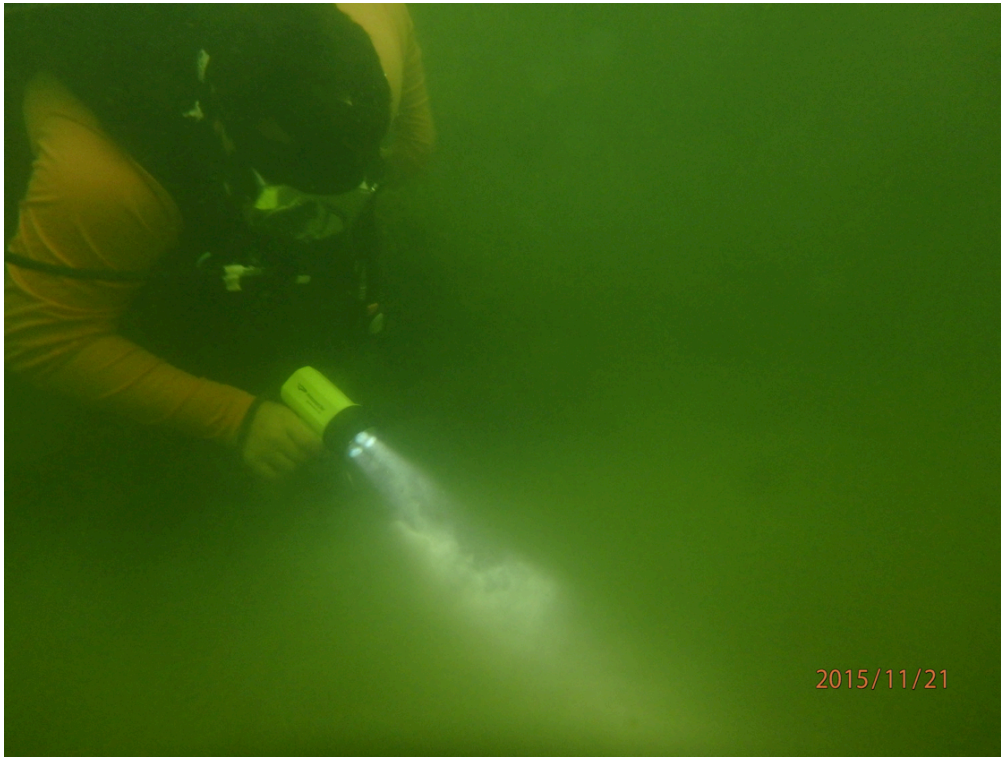
Figure 4.1: Researchers are required to use underwater lights in some canals due to low light penetration. The cloudy, yellow water indicates sulfur metabolism and hydrogen sulfide resulting from a lack of oxygen.

Seagrasses and other benthic vegetation require high light to grow. Monitored canals are visibly turbid with phytoplankton and organic material, sometimes with floating wrack blocking light entirely. The lack of seagrass and algae within the benthos and seawalls suggest insufficient light. Further, seagrass tissue  $\delta^{13}\text{C}$  was consistently lower than the average values for natural waters in the FL Keys, suggesting a low photosynthetic rate (due to a lack of light) relative to the abundance of  $\text{CO}_2$  in the environment (Fry et al. 1989).

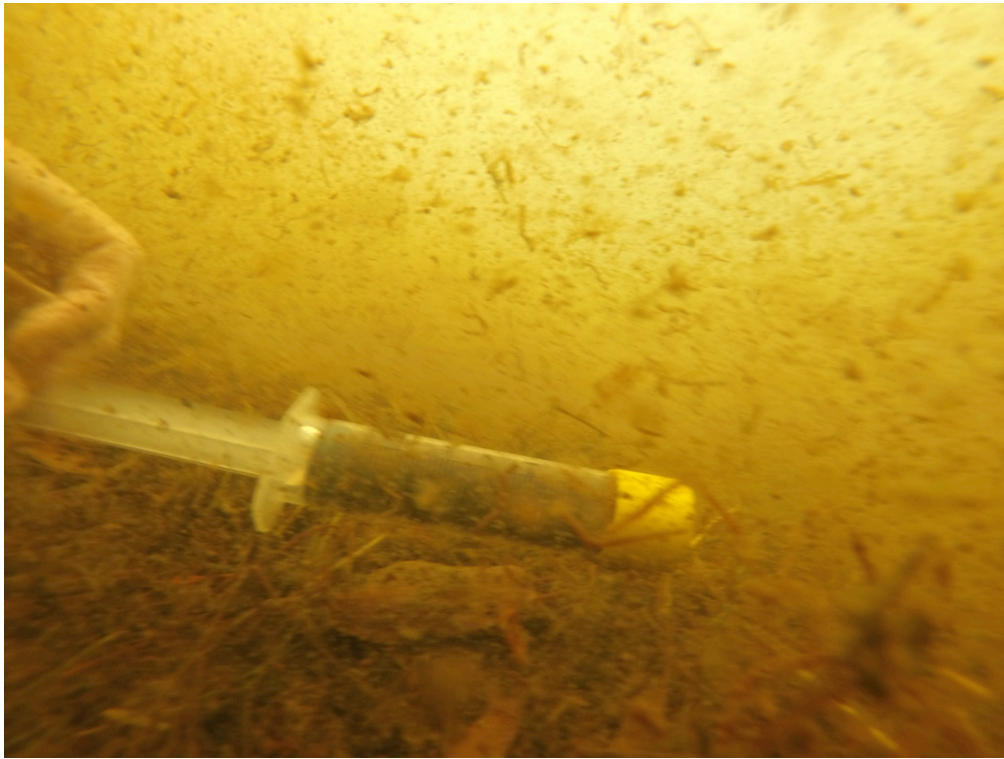
Figure 4.2: Unstable, low-density sediments of impaired canals can easily be disturbed. Note the dead leaves and plant detritus that dominate surface sediments rather than expected sand grains. The pictured device was used to remove cores of surface sediment for laboratory analysis.

Benthic plants and animals require firm, stable sediments in which to take root. Average baseline measurements of sediment density were lower than those within South Florida seagrass meadows, and likely too low for anchorage of any seagrass species (Fourqurean et al. 2012a; Fourqurean et al. 2012b). Low-density sediments like those found in the canals are not compacted/firm enough to support plants and can easily be overturned, stirred up, or moved. Furthermore, the high organic content and the recognition of partially decayed wrack within canal sediments suggest that these sediments are actively decomposing. Decomposition in sediments consumes oxygen (required by benthic plants and animals) and produces hydrogen sulfide (a toxic gas) after oxygen is depleted.

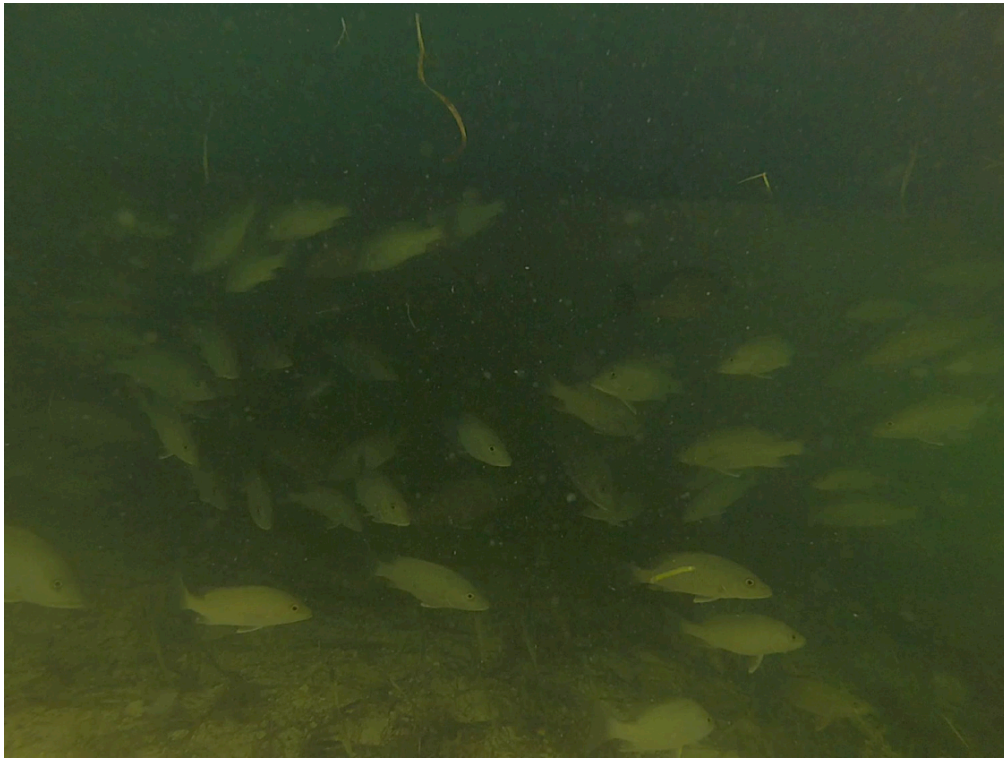
Figure 4.4: Dozens of Mangrove snapper observed in the rear of Canal 472 after the opening of the culvert.

Culverts had mixed effects on measured variables. In Canal 277, there was no measurable effect of the culvert on sediment characteristics, fish abundance or seawall diversity compared to the control or pre-treatment conditions. The increased circulation provided by culvert insulation was intended to primarily address water column conditions, thus the subsequent effects on sediment and vegetation may require additional time in order to be identified. During surveys, it was also noted that the adjacent water bodies to which the culvert connects are also impaired with anoxic benthos (cloudy, yellow water indicating sulfur metabolism) and accumulated, unconsolidated organic sediments. The culvert installed in Canal 472 resulted in improvements in sediment conditions, fish abundances and seawall inhabiting communities. Sediment depth decreased over 50 % in Canal 472, though occurred prior to the official opening of the culvert. Construction in the canal and preliminary openings alone could have flushed out or compacted sediments in the canal rear. Fish counts, seawall communities and benthic vegetation were improved compared to pre-culvert conditions and control but conclusions must be approached carefully as positive observations are scarce and pre-culvert culvert data in general is lacking.

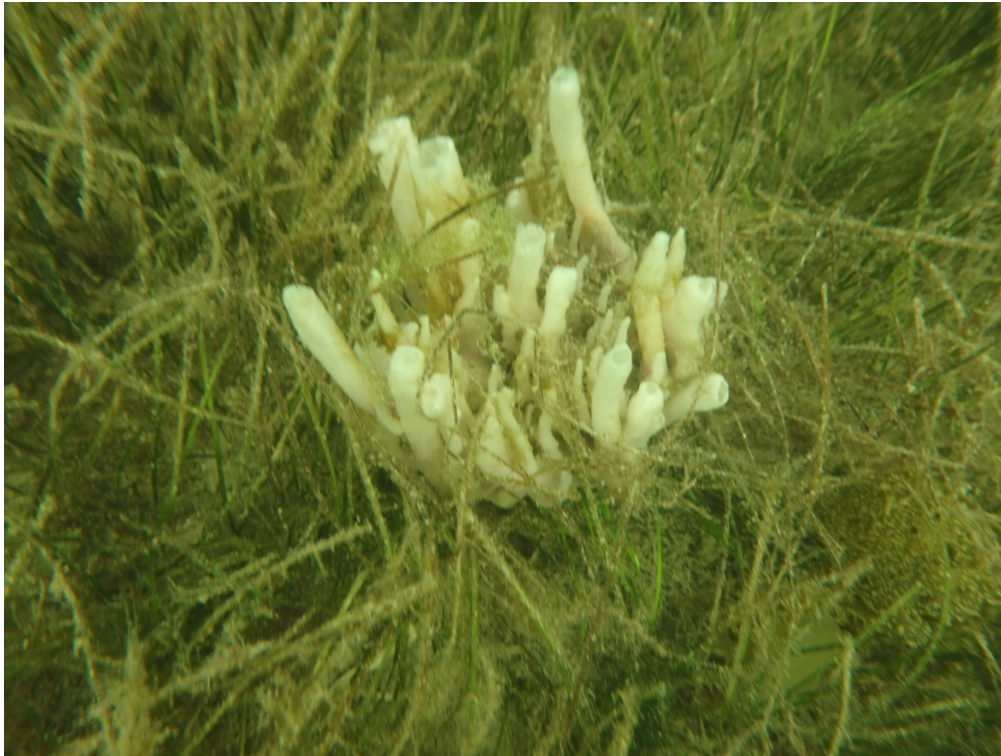
Figure 4.5: Sponge found in dense meadows of *Halodule wrightii* approximately a third into Canal 150. Benthic conditions in Canal 150 were consistently better compared to demonstration canals and other Islamorada project canals.

contained benthic macroalgae and seagrass *Halophila*, suggesting a low-light environment but light and sediment conditions that are still adequate for benthic vegetation. This canal is lined on one side by residential housing though maintains natural vegetation and shoreline on the other potential contributing to overall canal health. The canal is also 90 ft wide at its most narrow, allowing for better dilution and circulation compared to other canals.
