# Monroe County Canal Remediation Benthic Monitoring Program May 2018 Report

### Sara Wilson, Dr. Jason Howard, and Dr. Jim Fourqurean

Water Quality Protection Program Canal Subcommittee Meeting May 23<sup>rd</sup>, 2018 – Marathon, FL

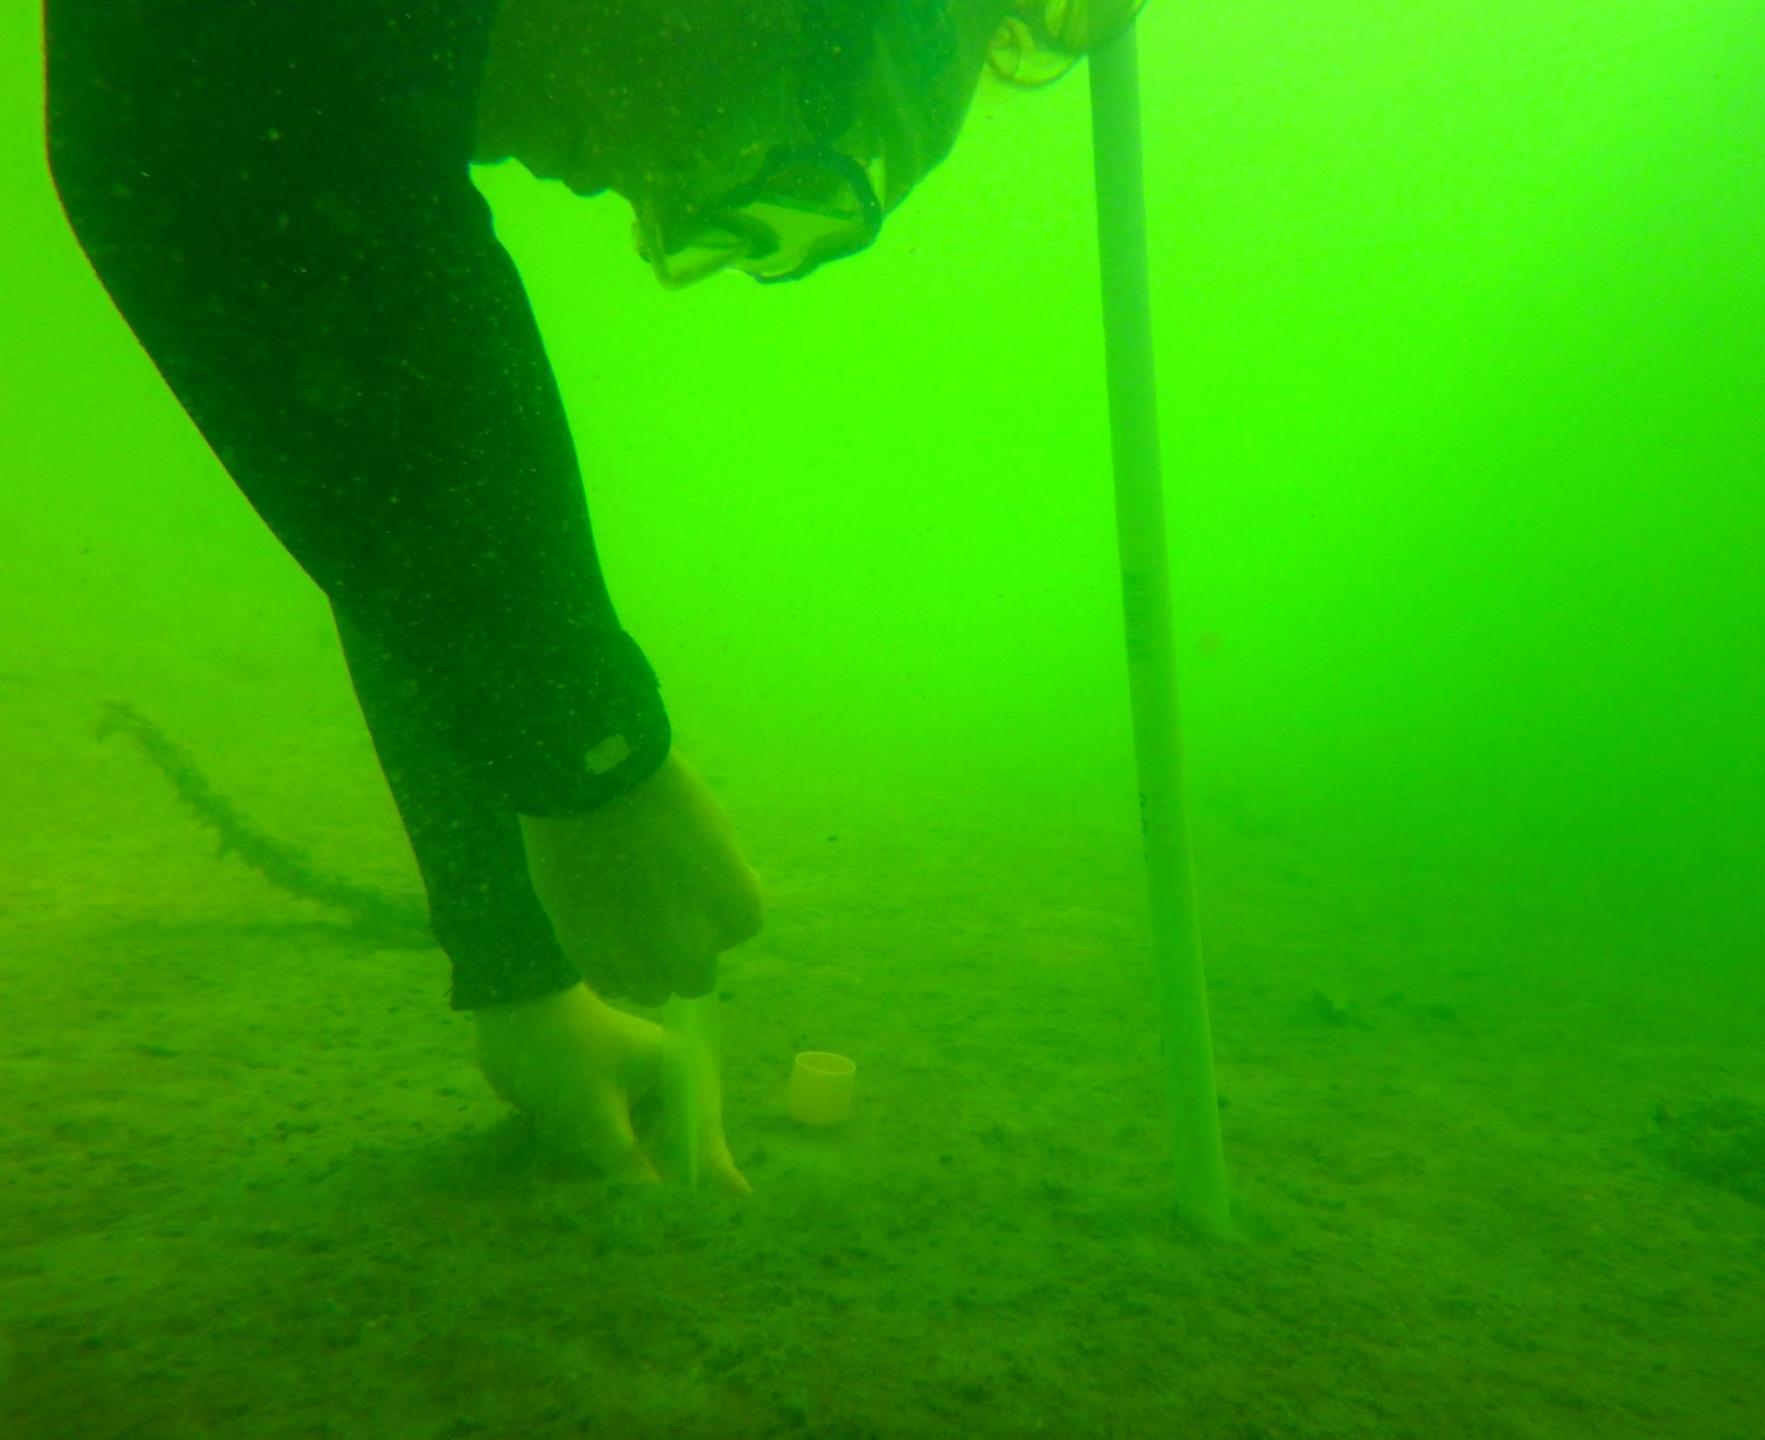
Sediment or 'Muck' measurements

### Muck depth

Quick and dirty estimate of muck layer thickness

Sediment dry bulk density (DBD)

- Bulk density is the weight of a standardized sediment sample after the water has been evaporated out
- Fluffy, muddy sediments have a lower DBD than coarse, sandy sediments or fill material

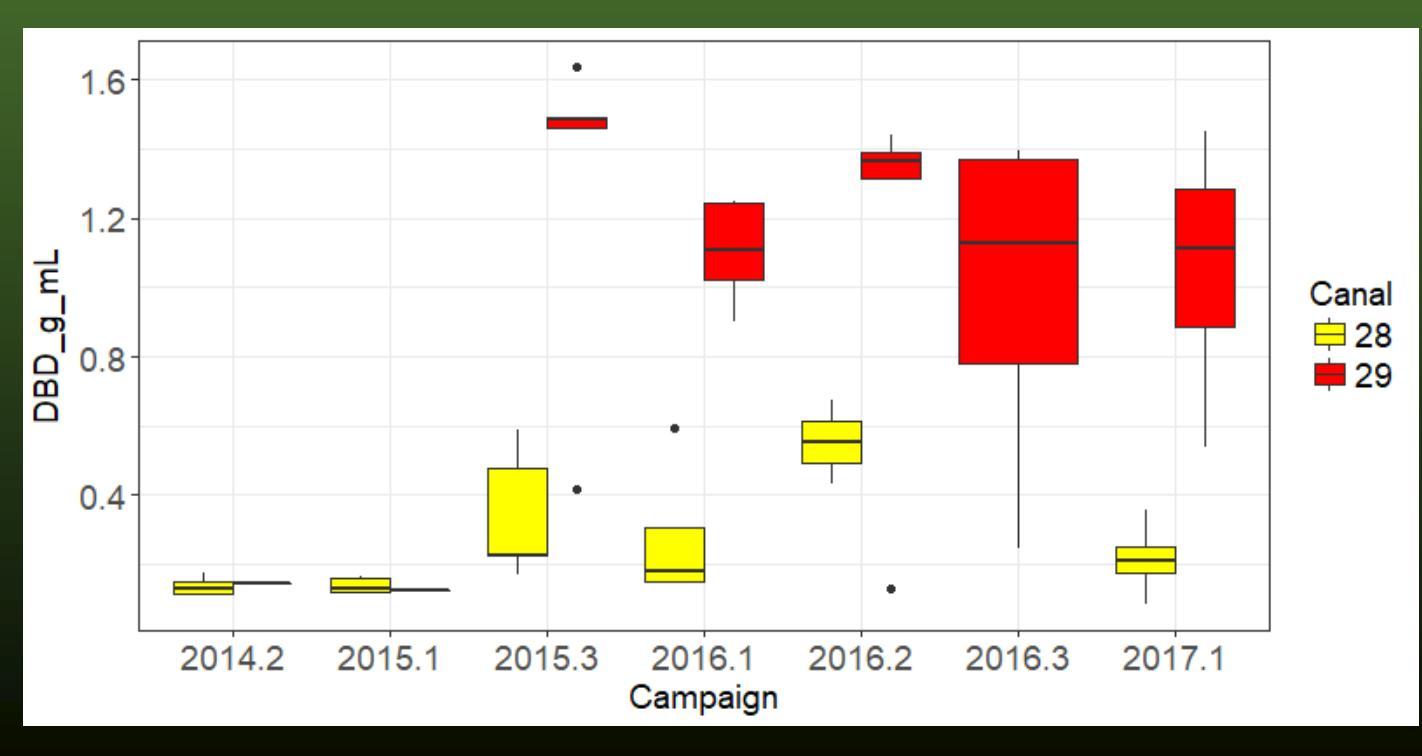
Fluffy, fine mud sediment has a low DBD and coarse, sandy sediment has a higher DBD.

**C28** has lower DBD than **C29**.

However, significant changes in sediment chemistry of Canal 28 compared to Canal 29

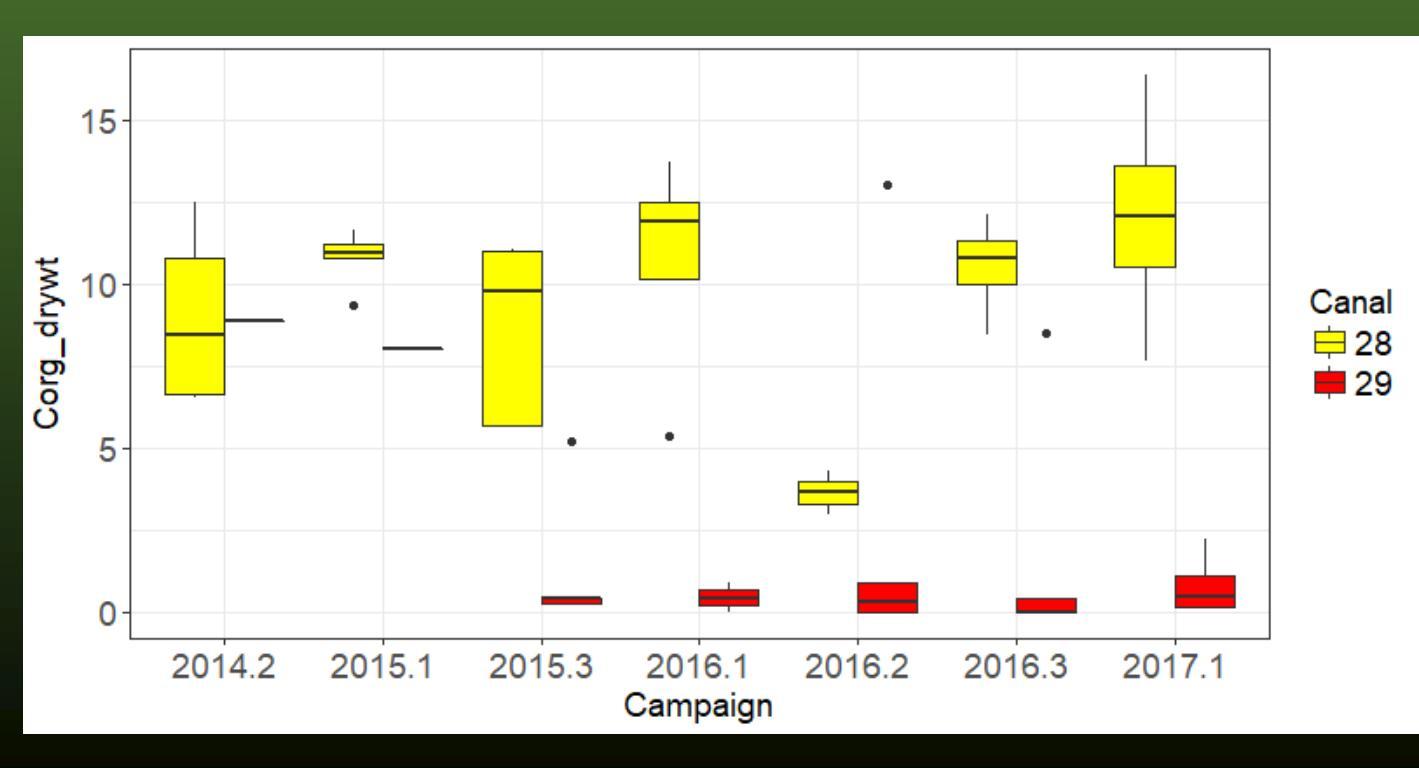
Fluffy, fine mud sediment has more Corg and coarse, sandy sediment has a less Corg.

C28 has higher sediment Corg than C29.

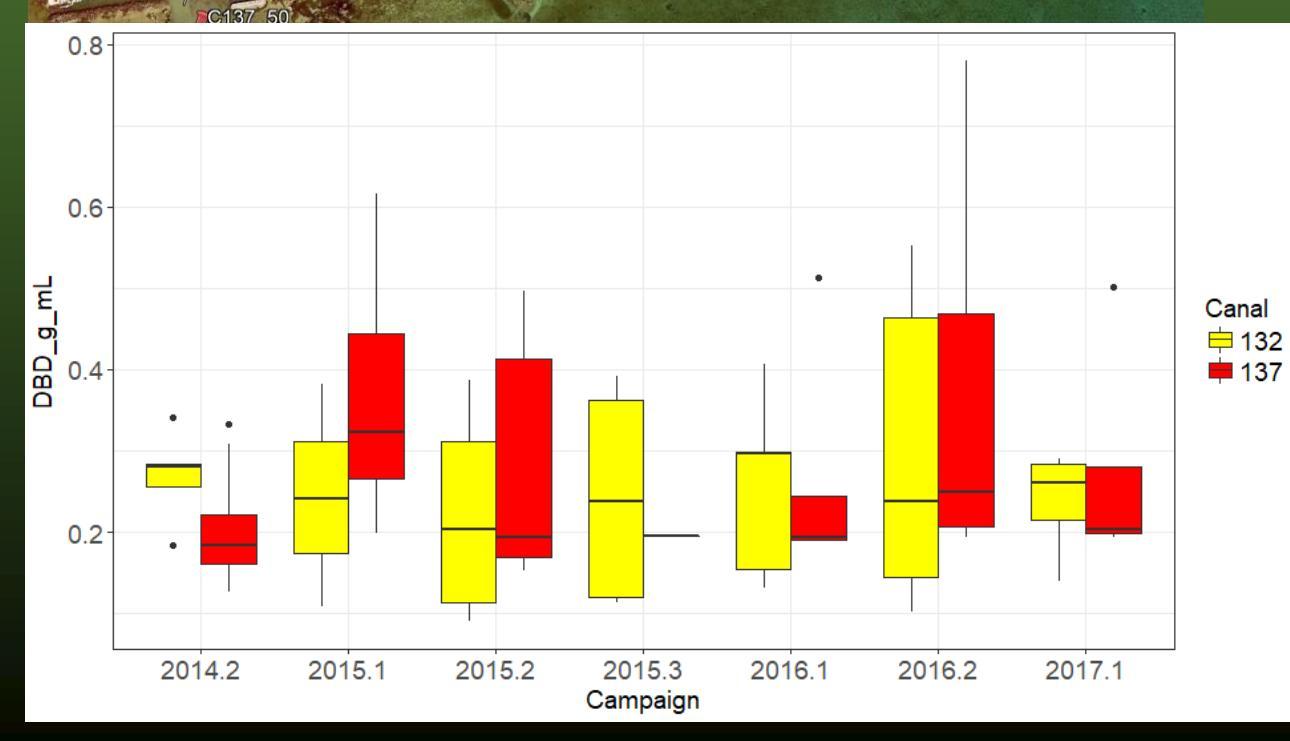
Fluffy, fine mud sediment has a low DBD and coarse, sandy sediment has a higher DBD.

C132 and C137 show no differences in sediment DBD.

No major difference in sediment DBD between canals, but there are significant differences in sediment chemistry of Canal 132 compared to Canal 137

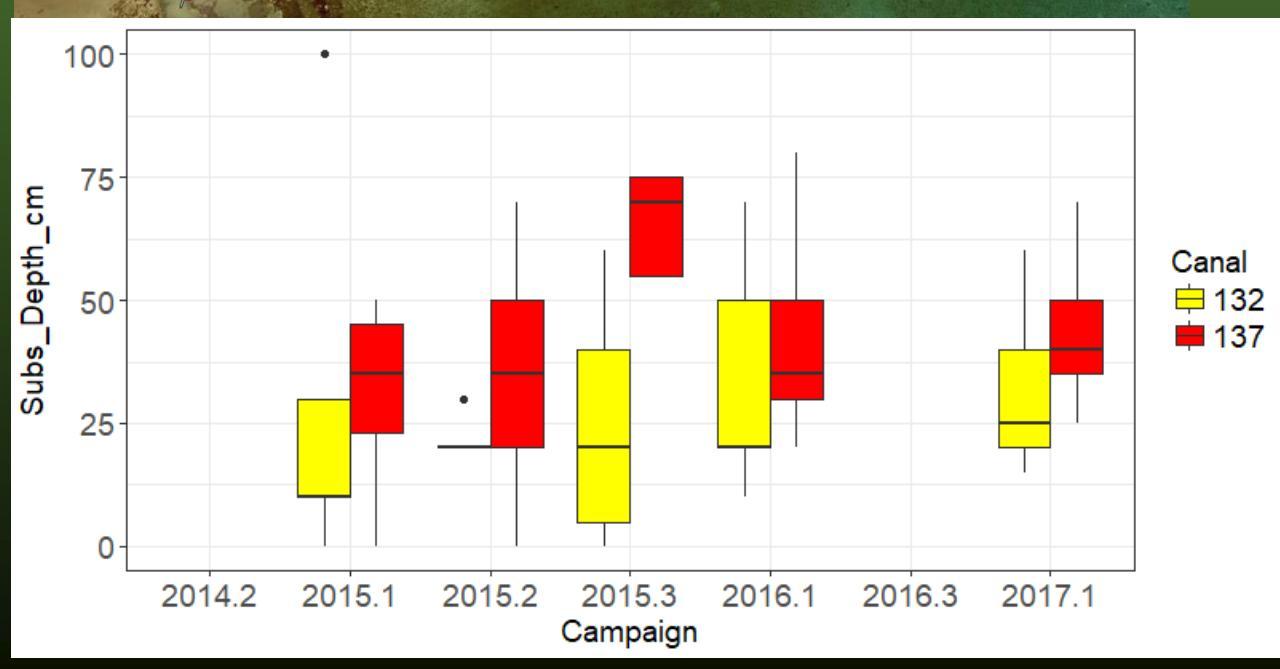
We infer that a greater substrate ('muck') depth indicates greater Corg loading from wrack deposits.

C137 has a greater muck depth than C132.

Surprisingly, Canal 137 has greater muck depth and higher sediment Corg than Canal 132. This data does not demonstrate that the weed curtain has helped Canal 137.

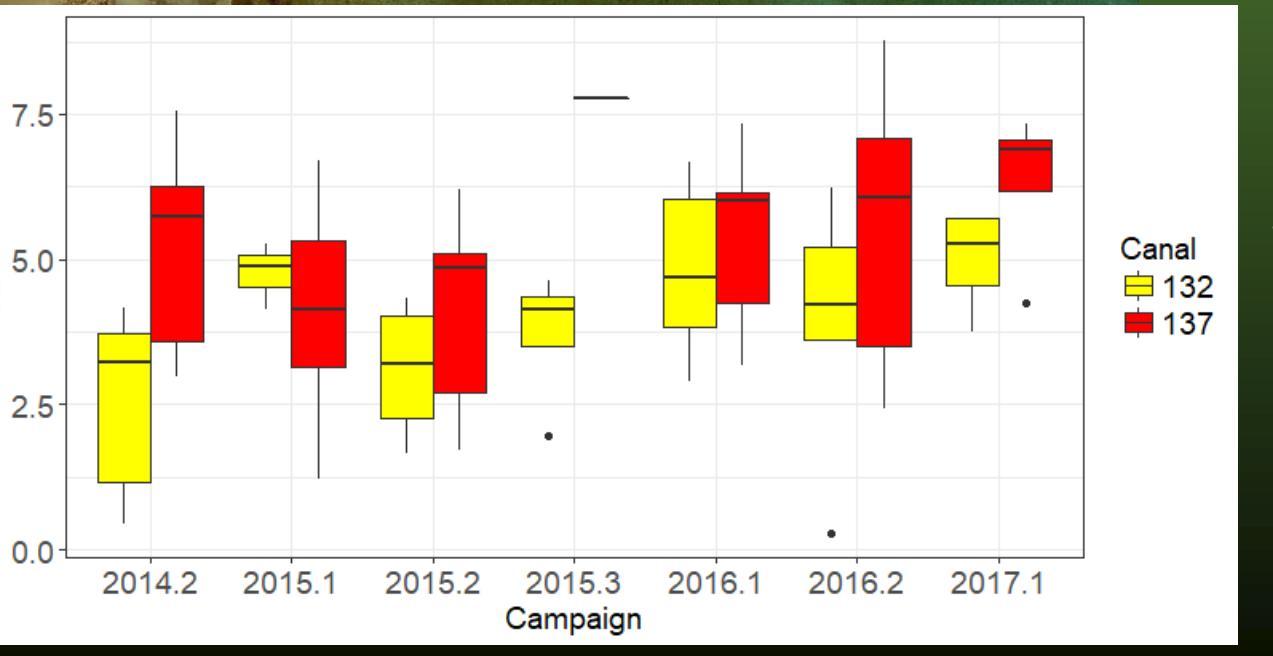
Corg\_drywt

Fluffy, fine mud sediment has more Corg and coarse, sandy sediment has a less Corg.

C137 has higher sediment Corg than C132.

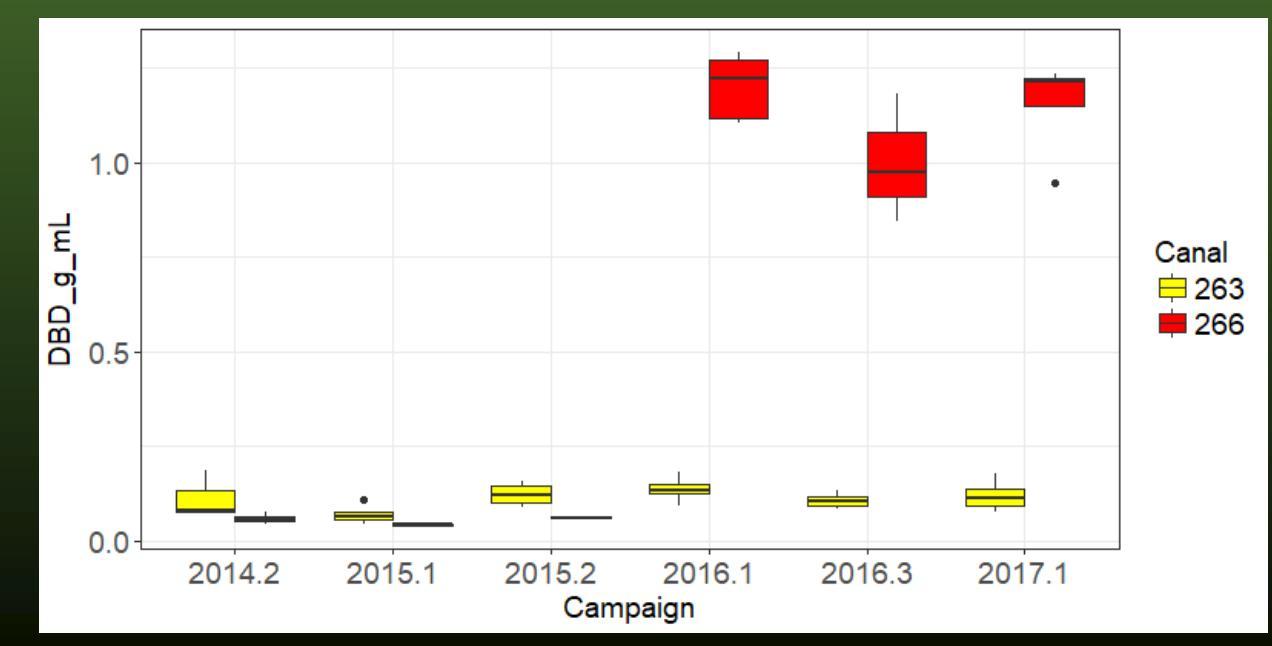
Fluffy, fine mud sediment has a low DBD and coarse, sandy sediment has a higher DBD.

C266 has higher DBD than C263.

Significant difference in sediment DBD, muck depth, and Corg between canals, also significant pre-dredge and post-dredge differences in Canal 266

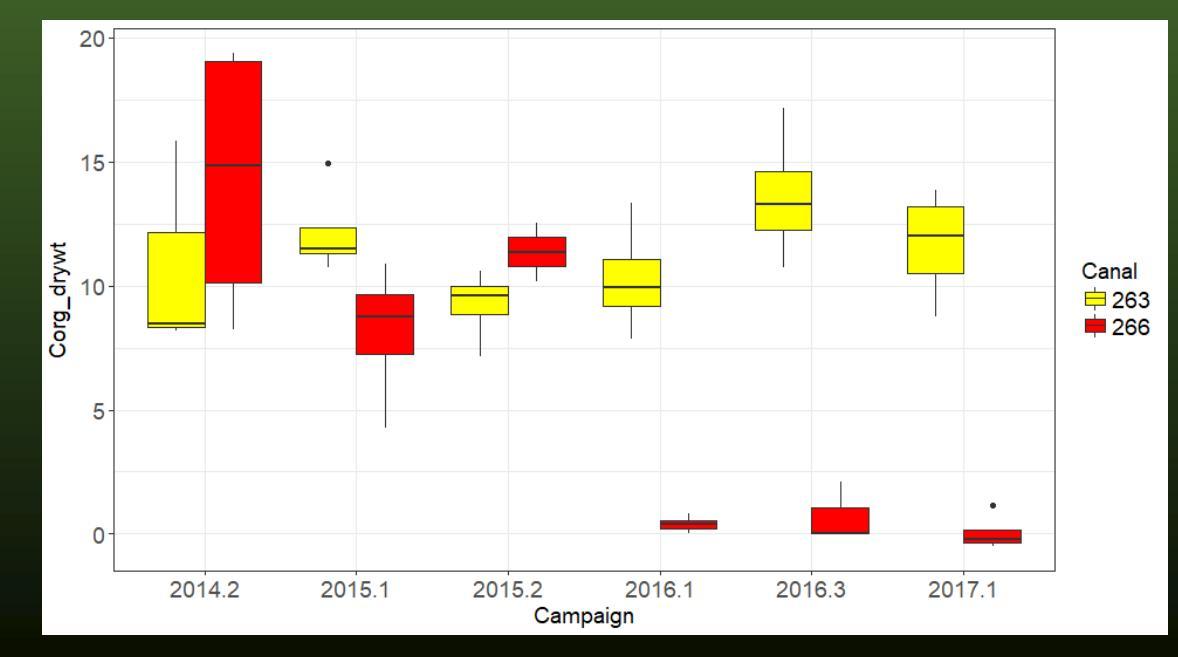
Fluffy, fine mud sediment has more Corg and coarse, sandy sediment has a less Corg.

C263 has higher sediment Corg than C266.
