#### Canal Restoration in Monroe County Benthic Monitoring Report

Jason Howard and James Fourqurean Seagrass Ecosystems Research Lab Florida International University

> FKNMS Steering Committee Meeting September 7<sup>th</sup>, 2016

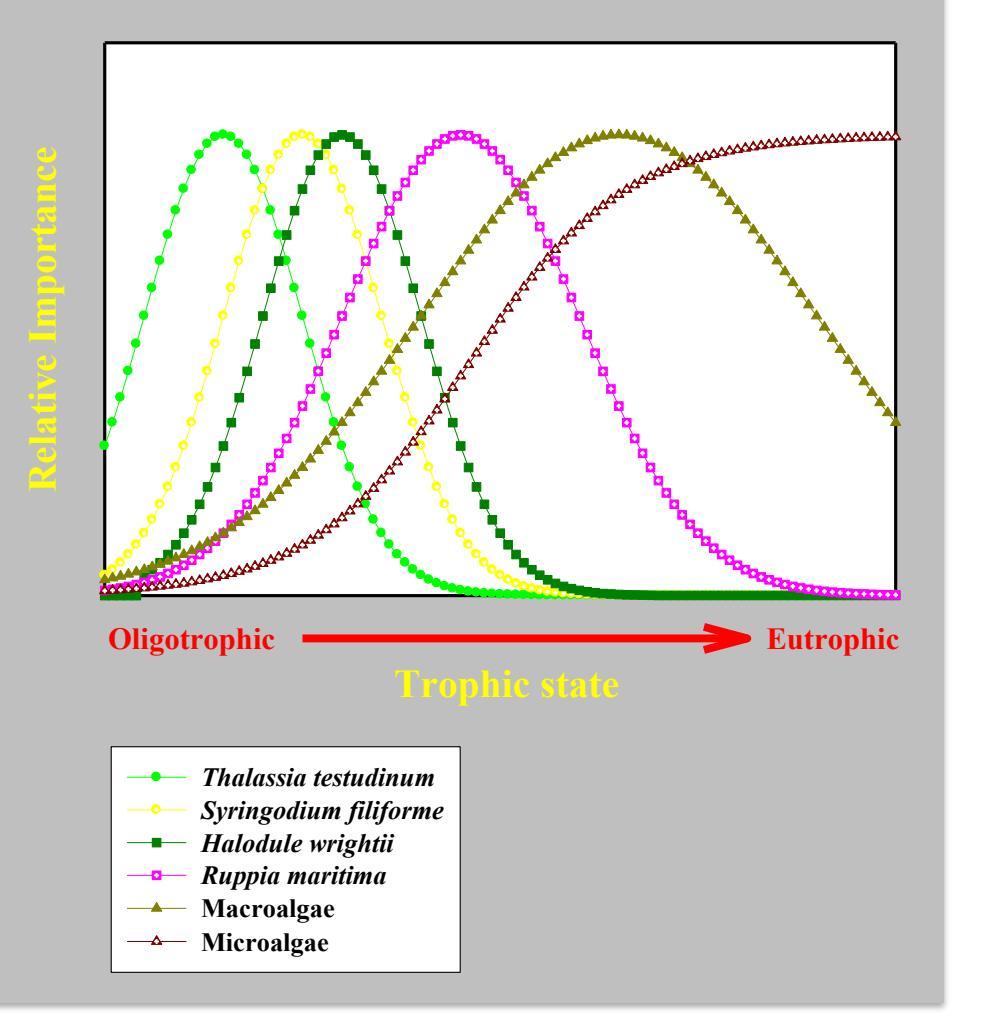
#### Eutrophication model

## Explicit model of ecosystem behavior #1

Nutrient pollution will lead to changes in relative abundances of primary producers in a predictable way.

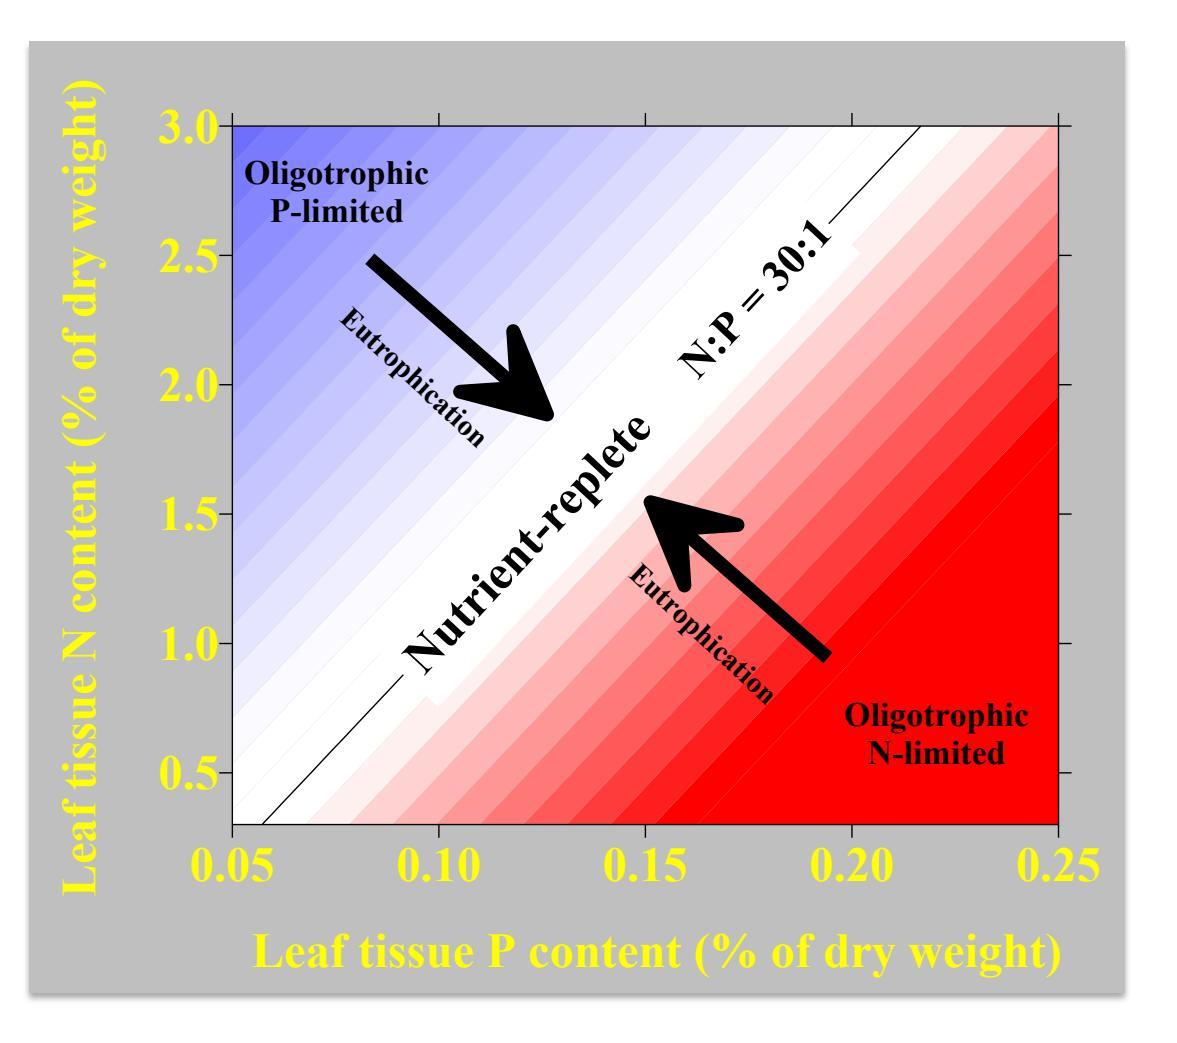
## Explicit model of ecosystem behavior #2

Nutrient pollution will shift N:P ratios of primary producers towards a taxonspecific "Redfield ratio"

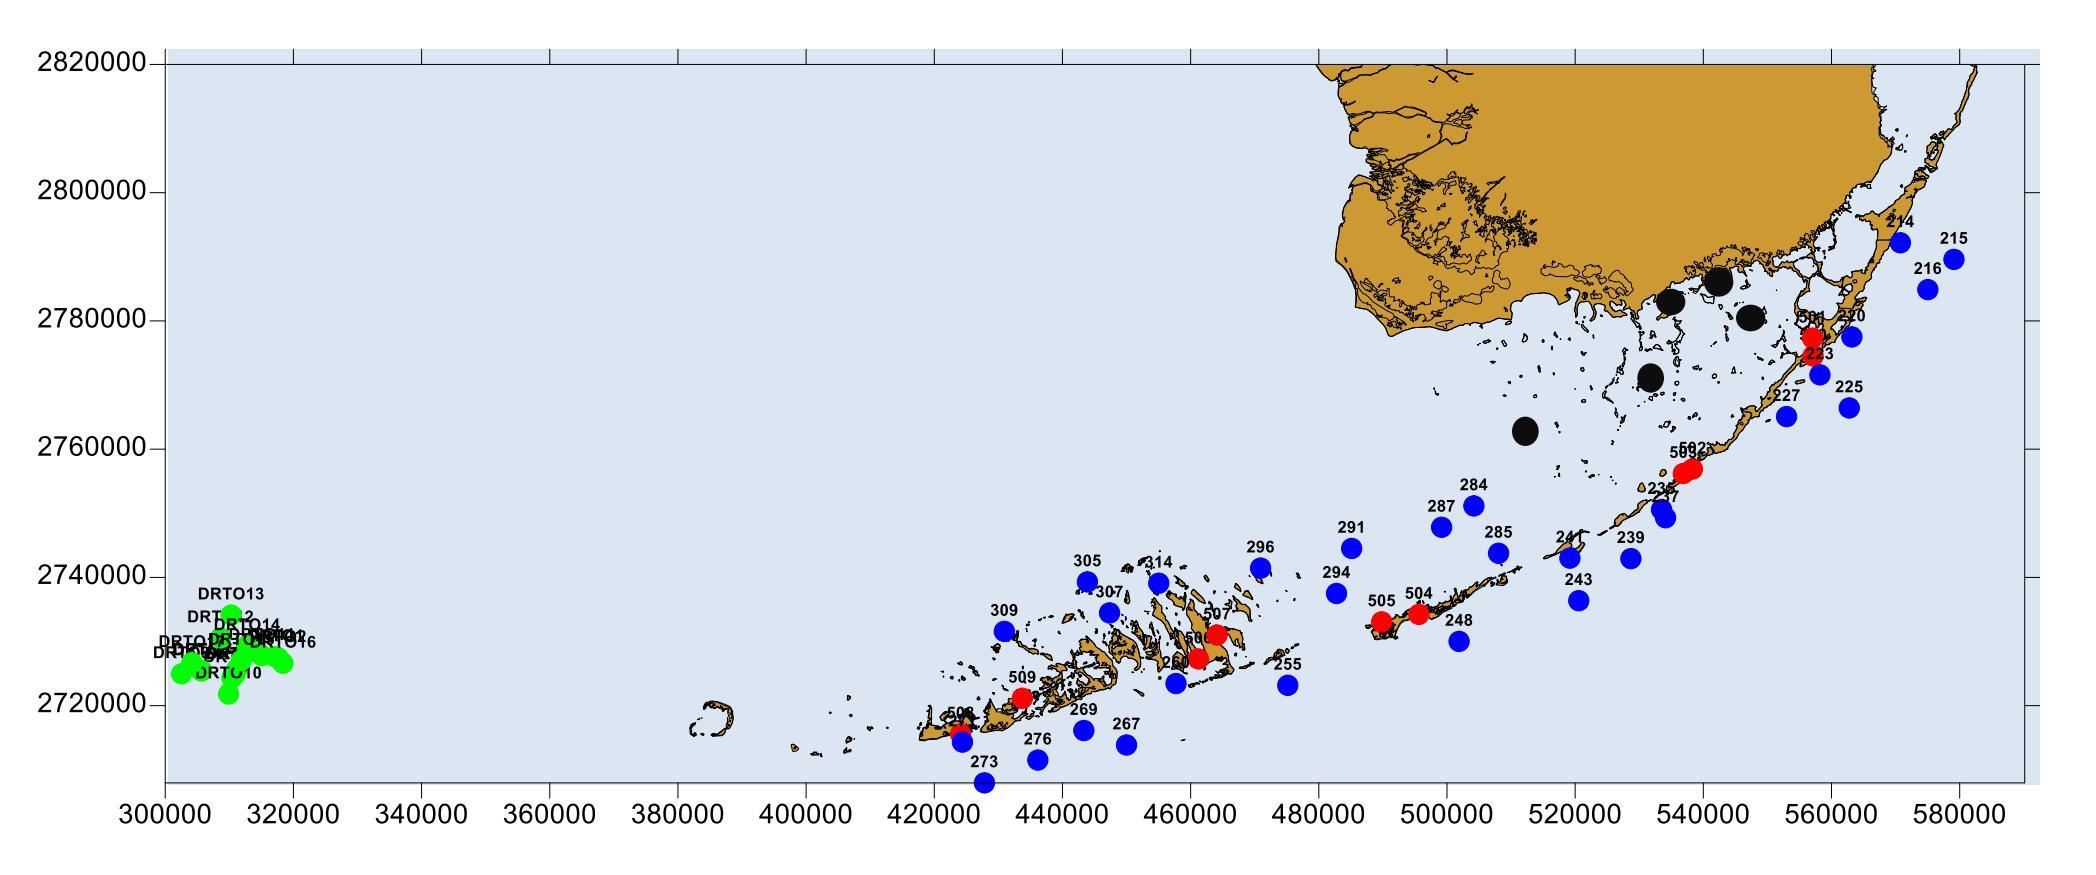
#### Original 30 sites (1995)

- 17 sites in Dry Tortugas (2011)
- 10 sites for nearshore emphasis (2012)

5 sites for Everglades LTER (2000)

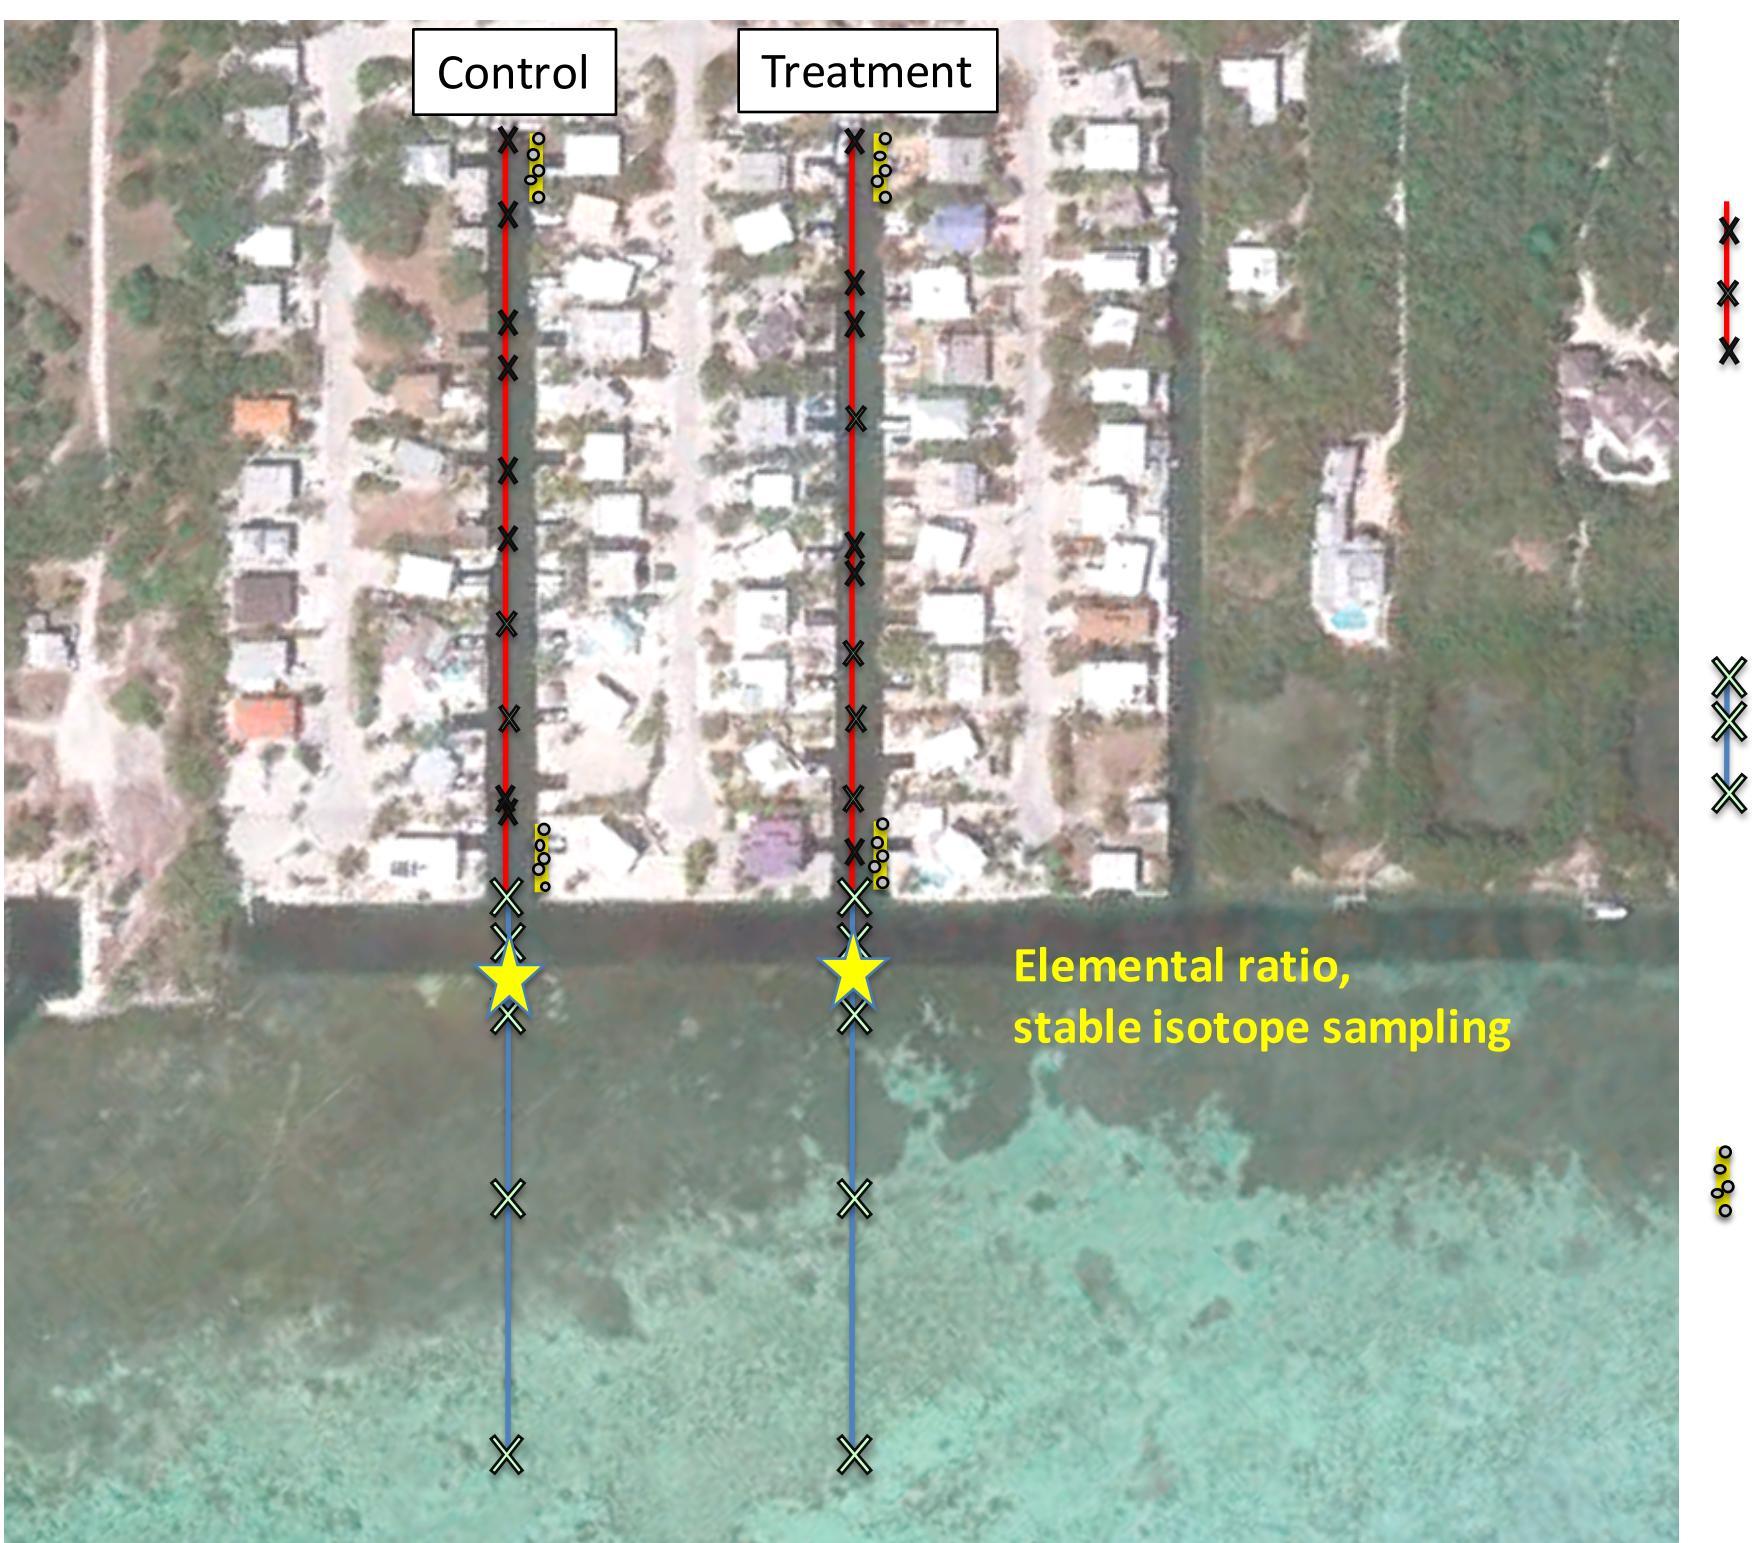
25cm x 25cm randomly placed for benthic coverage

25cm x 25cm set sites for benthic coverage

10cm x 10cm randomly placed for canal wall coverage

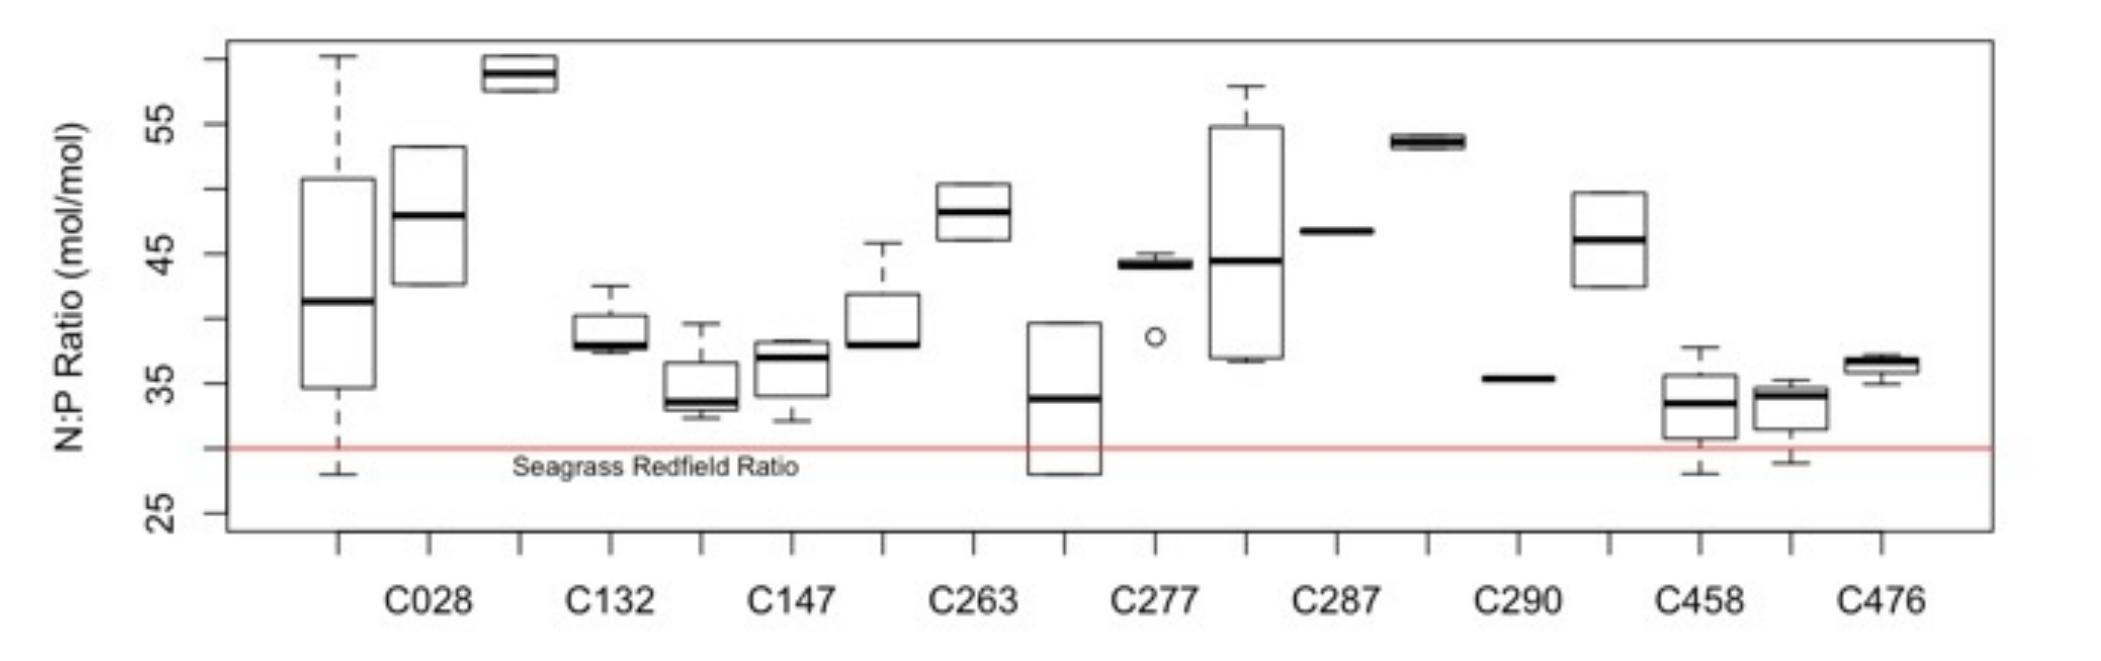
#### Effect on Seagrasses

# N:P

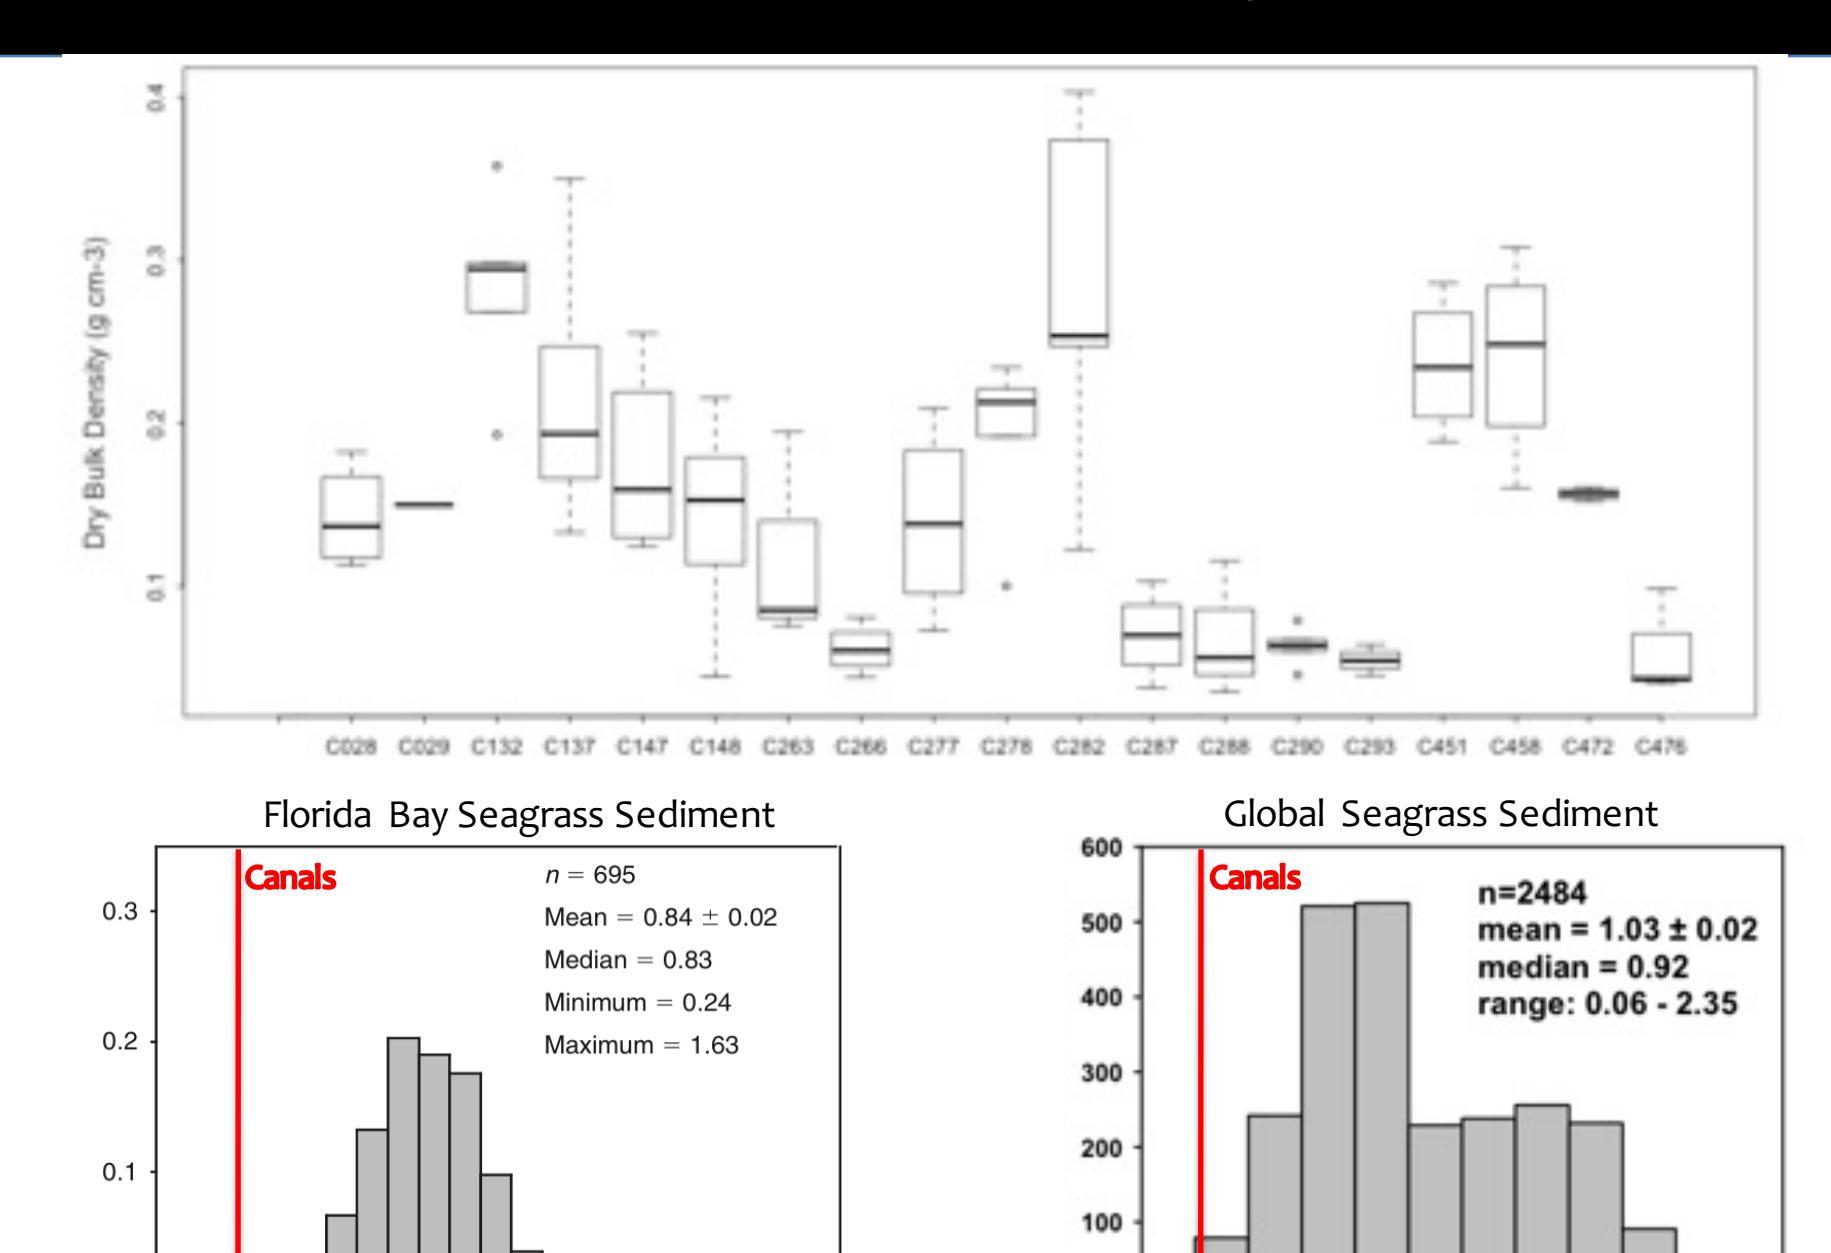
#### Sediment Density

Density (g cm<sup>-3</sup>)
